August 14, 2018
EE&G Project No. 2018-2434

**Subject: Asbestos Pre-Demolition Survey
Former Apartment Building and Rear Structures
6410 5th Street
Stock Island, Florida 33040**

Former Apartment Building and Rear Structures – 6410 5th Street, Stock Island, FL

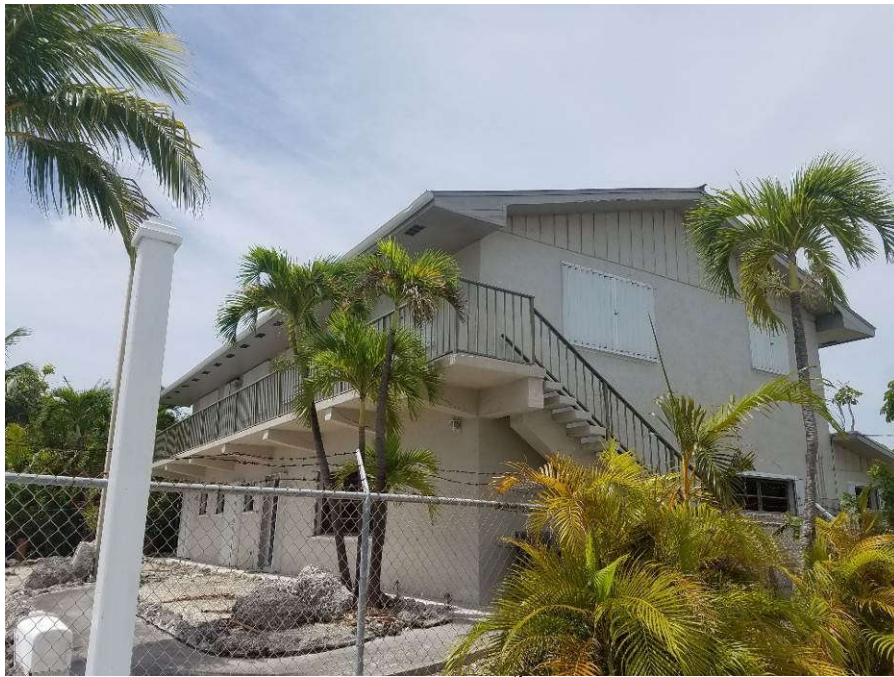
Photo 1: Subject building – 6410 5th Street, Stock Island, FL.

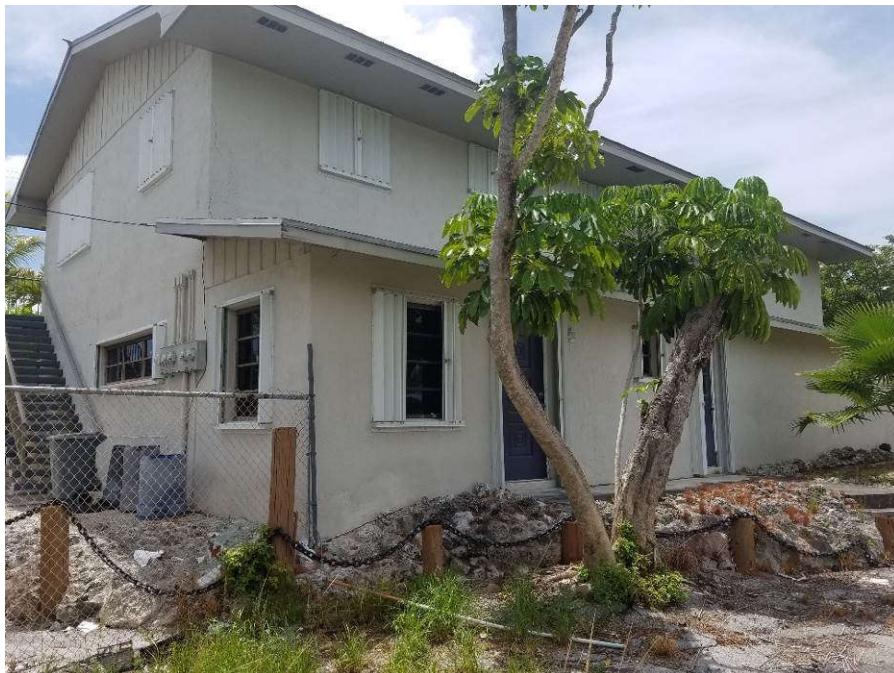
Photo 2: Subject building – 6410 5th Street, Stock Island, FL.

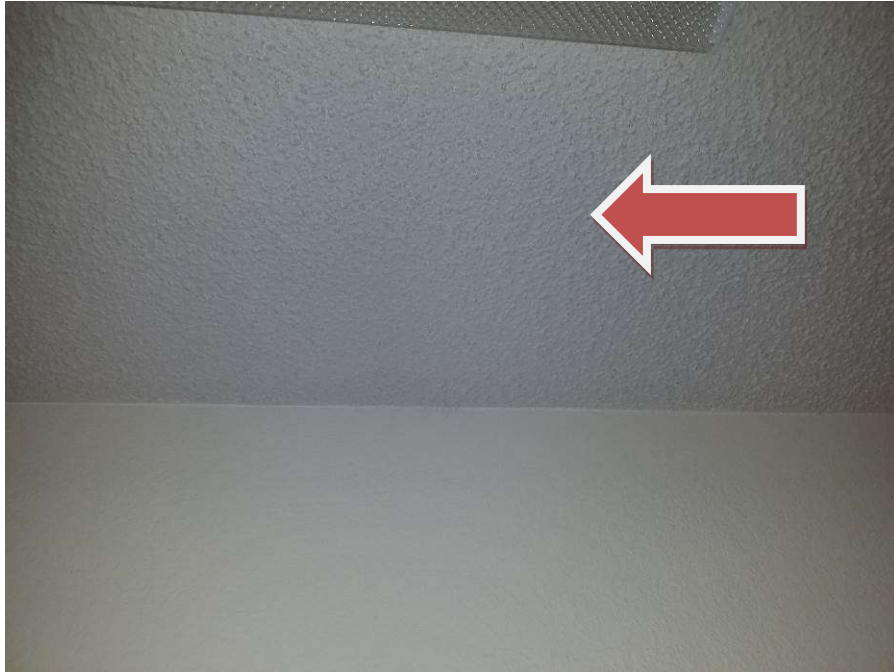
Asbestos was found in amounts greater than 1 percent in the plaster ceiling finish (popcorn ceiling) and therefore is considered ACM. There was approximately 3,600 square feet on the first and second floor areas of the former apartment building.

The white plaster ceiling finish (popcorn ceiling) was found to be ACM. If other specific areas at this location are to be impacted during planned renovations, an asbestos survey of these areas will be required. Suspect materials discovered after this inspection should be sampled and analyzed to determine asbestos content and to initiate appropriate responses.

Photo 3: Typical RACM white plaster ceiling finish (popcorn ceiling) on floor 1.

The plaster ceiling finish (popcorn ceiling) was identified as RACM. This material must be removed prior to renovation or demolition activities that will crush, abrade, or pulverize its matrix. Removal and disposal of this material must be performed by a Florida-licensed Asbestos Contractor.

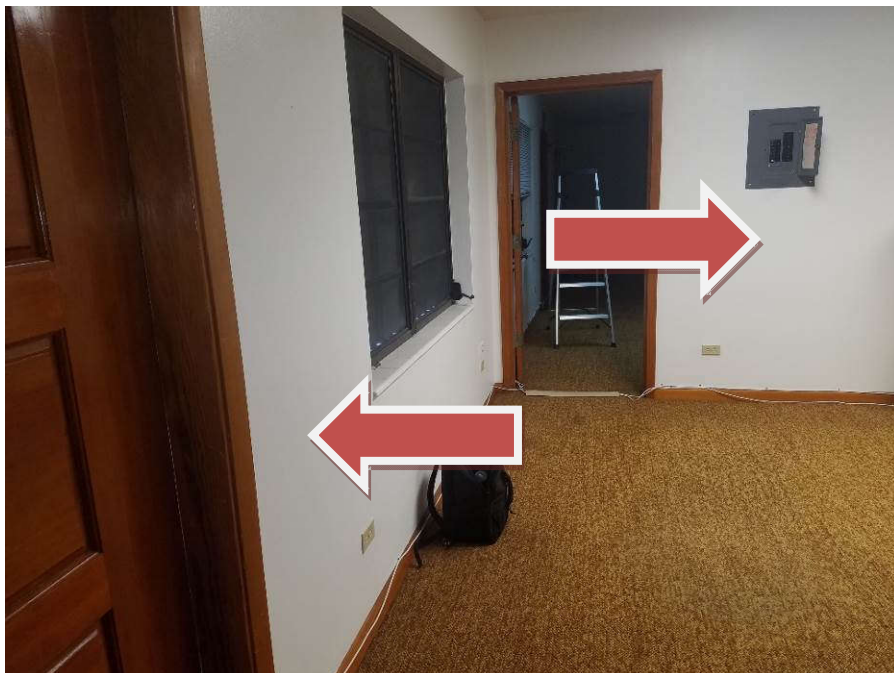
Samples collected of the drywall system were found to contain less than 1 percent chrysotile asbestos. According to EPA, these materials are not regulated as ACM, but OSHA considers materials with even trace amounts of asbestos a potential hazard to workers exposed to the airborne dust from these materials. EE&G recommends that contractors performing this work follow OSHA requirements to use dust control methods to assure that minor amounts of asbestos fibers do not become airborne, that employees involved in this work wear appropriate personal and respiratory protection, and exposure assessments be performed to determine if workers are being exposed to airborne asbestos fibers above the OSHA Permissible Exposure Limit (PEL) of a 0.1 fiber/cc 8-hour TWA PEL and a 1fiber/cc 30-minute excursion limit.

Photo 4: Typical <1 % asbestos drywall system.

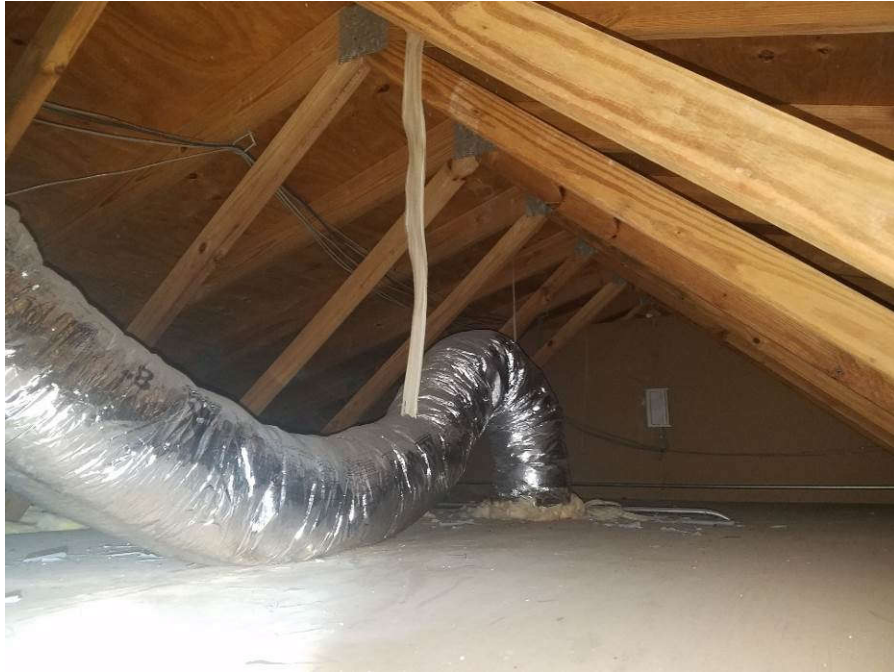
Photo 5: Typical ductwork observed during this inspection.

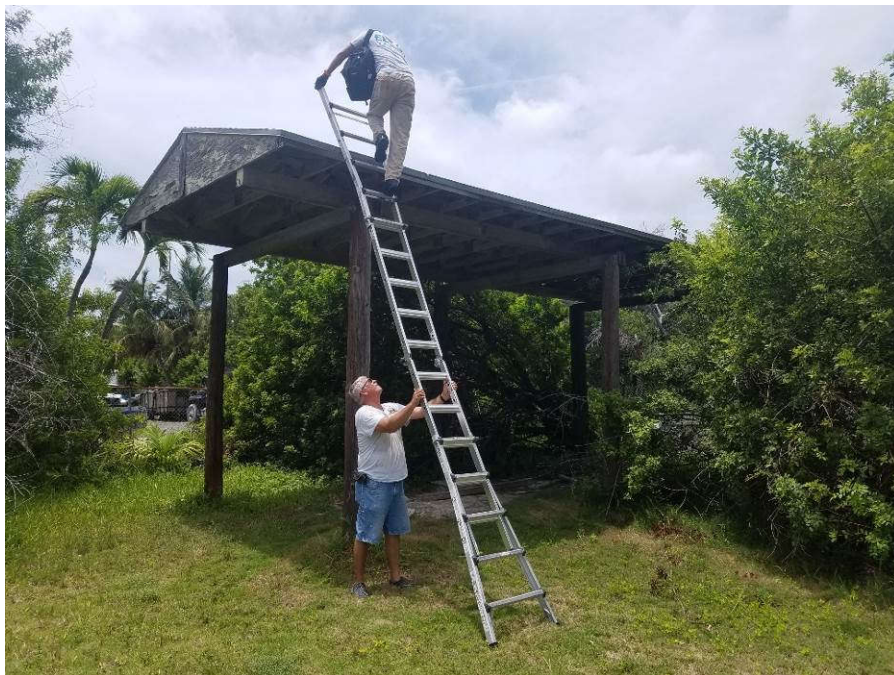
Photo 6: Wood canopy located on the rear of the property.

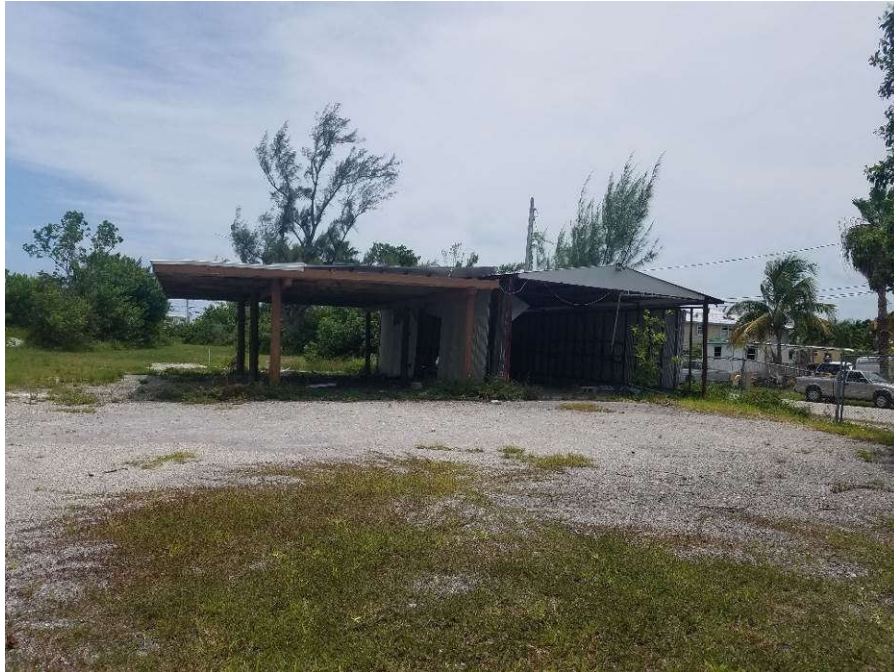
Photo 7: Metal shed located at the rear of the property.

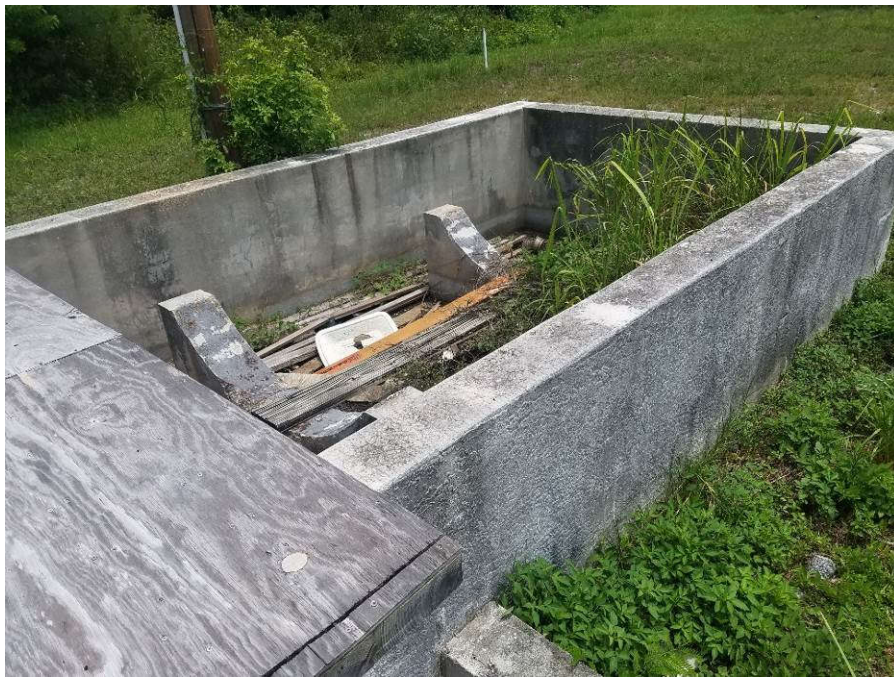
Photo 8: Concrete storage tank barrier/wall.
