BUILDING REPLACEMENT STUDY

SUGARLOAF SCHOOL

SUGARLOAF KEY, FLORIDA

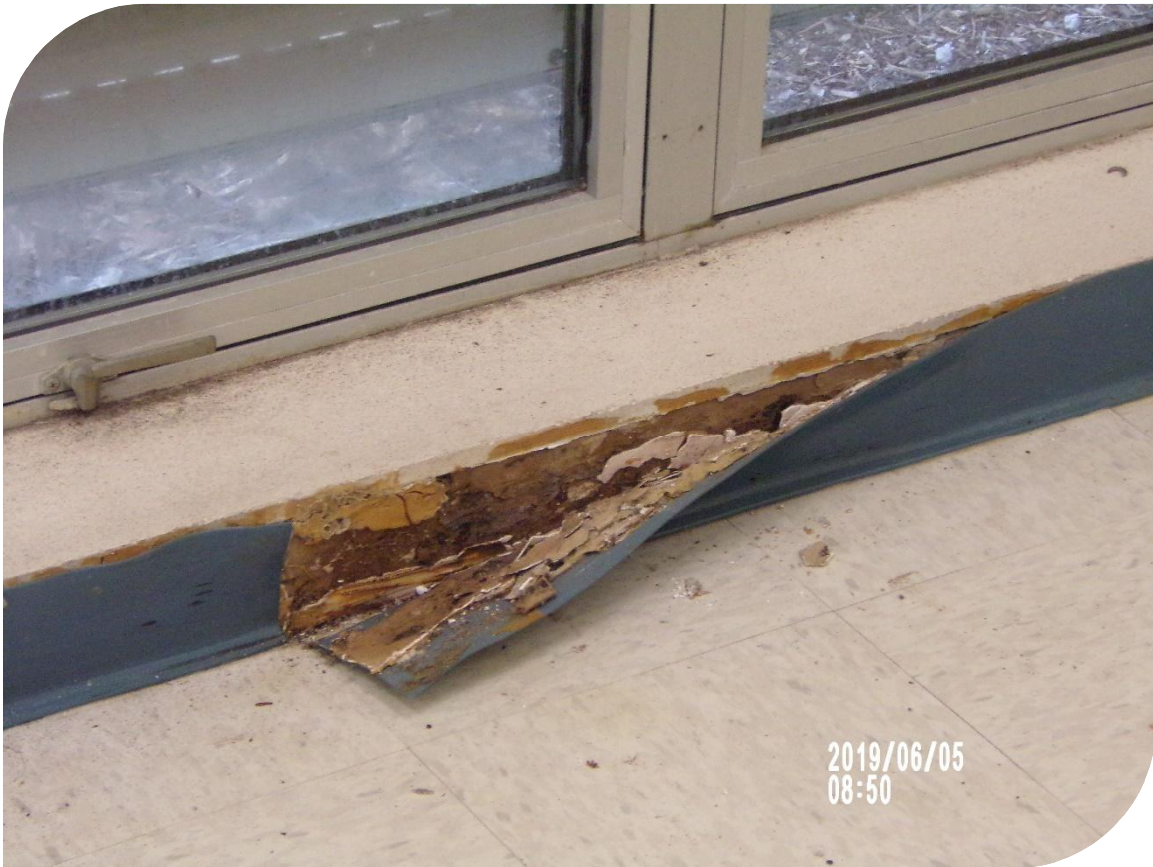
Damage from flooding

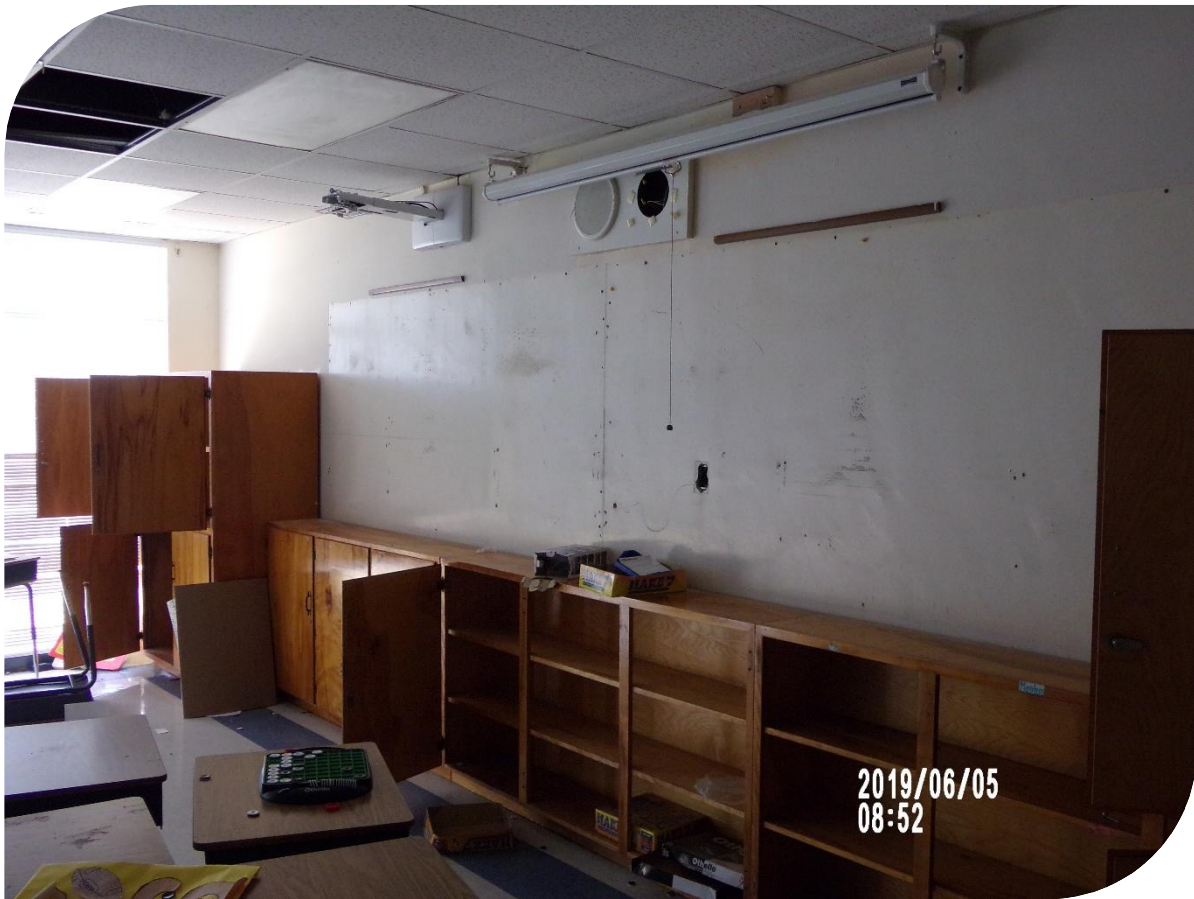
Ceiling Damage from Leaks

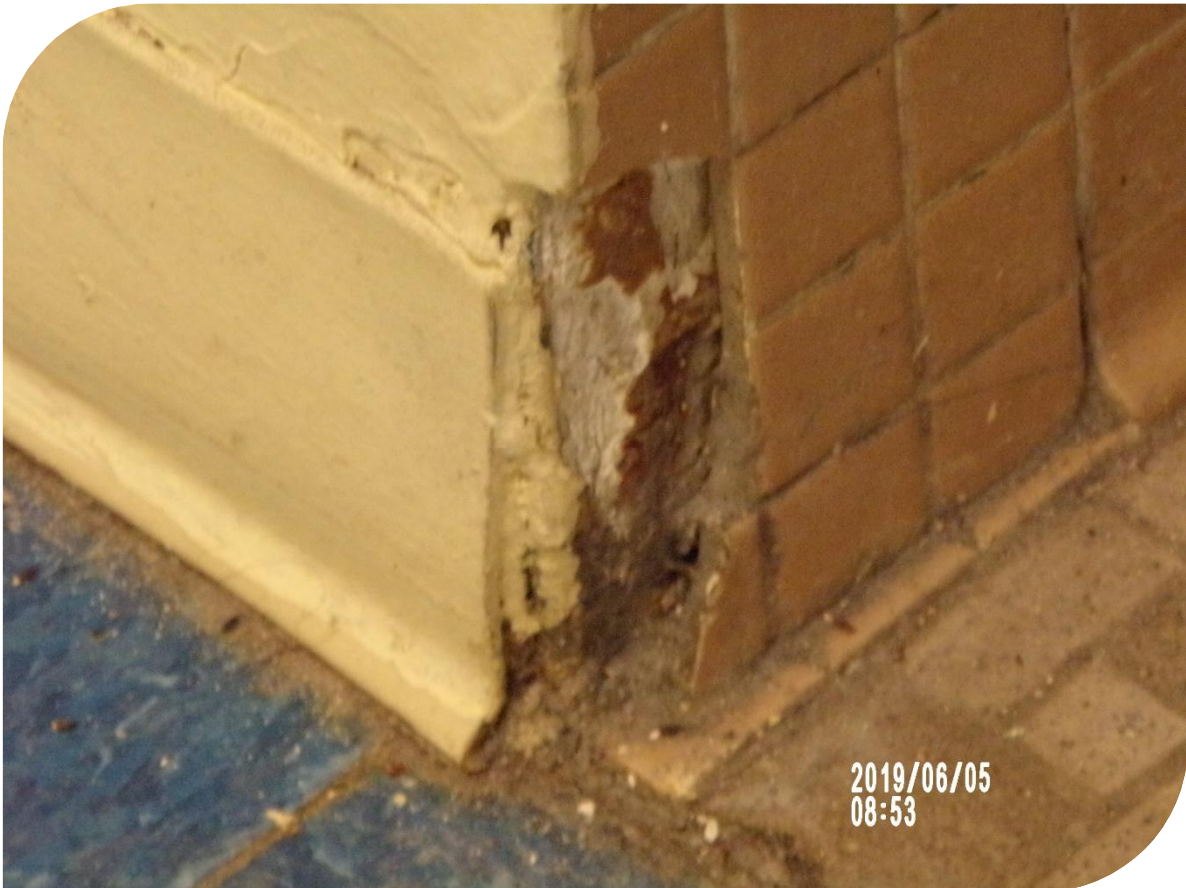
Antiquated casework and moisture intrusion behind white boards

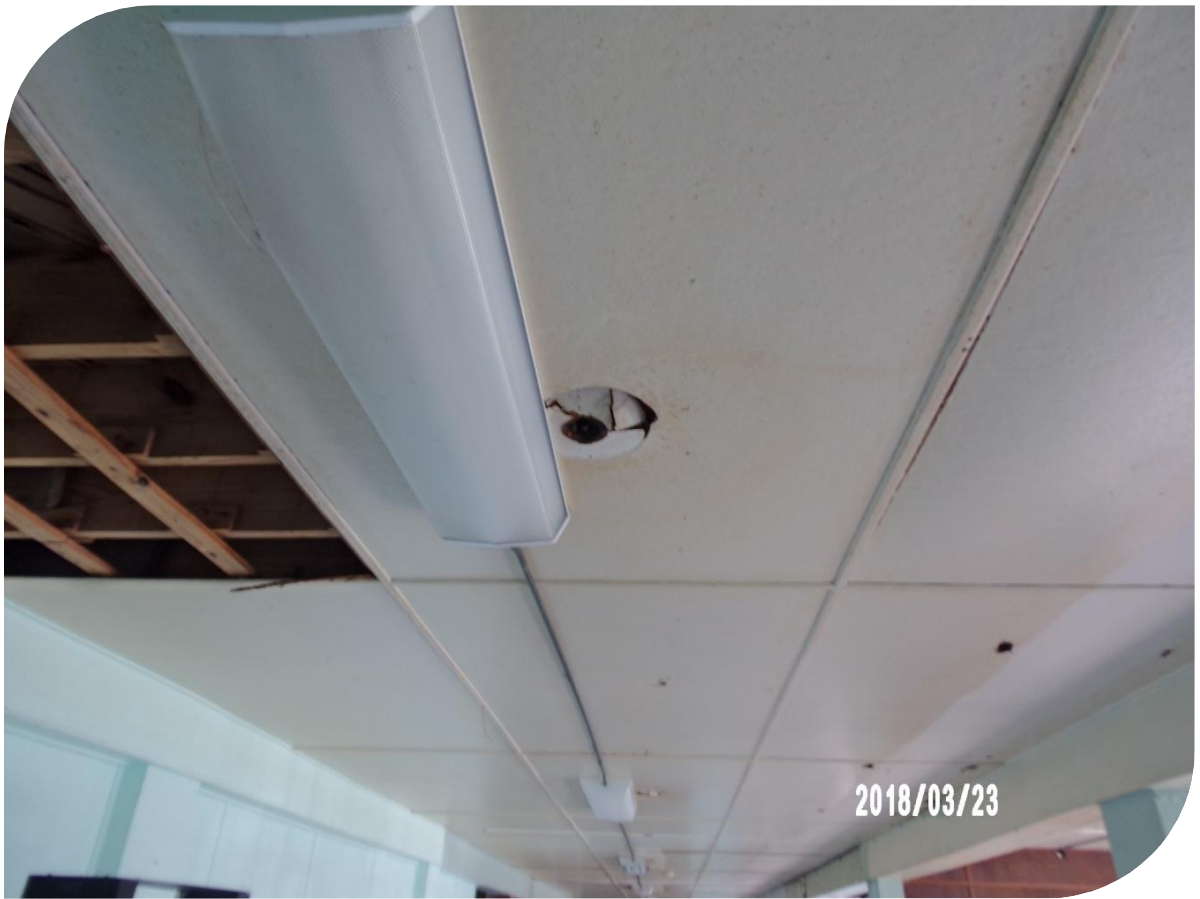
Hallway Damage

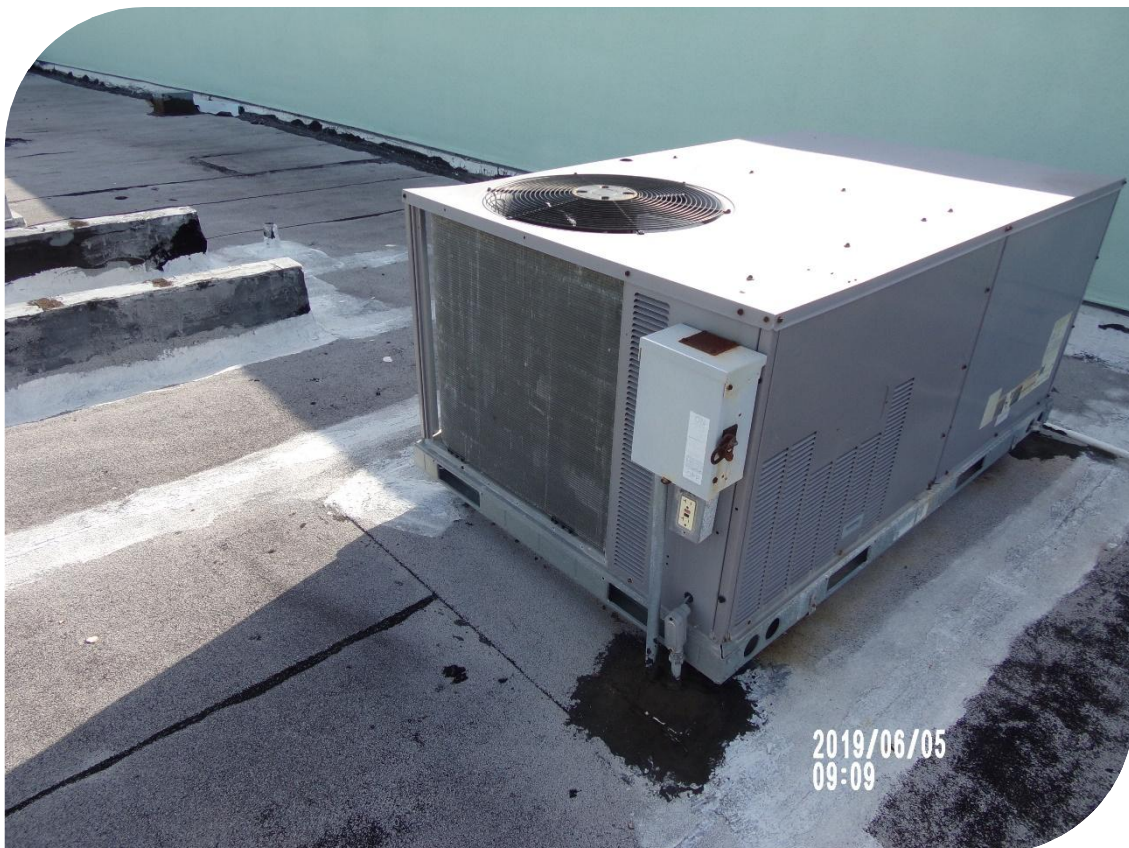
Roof in need of replacement

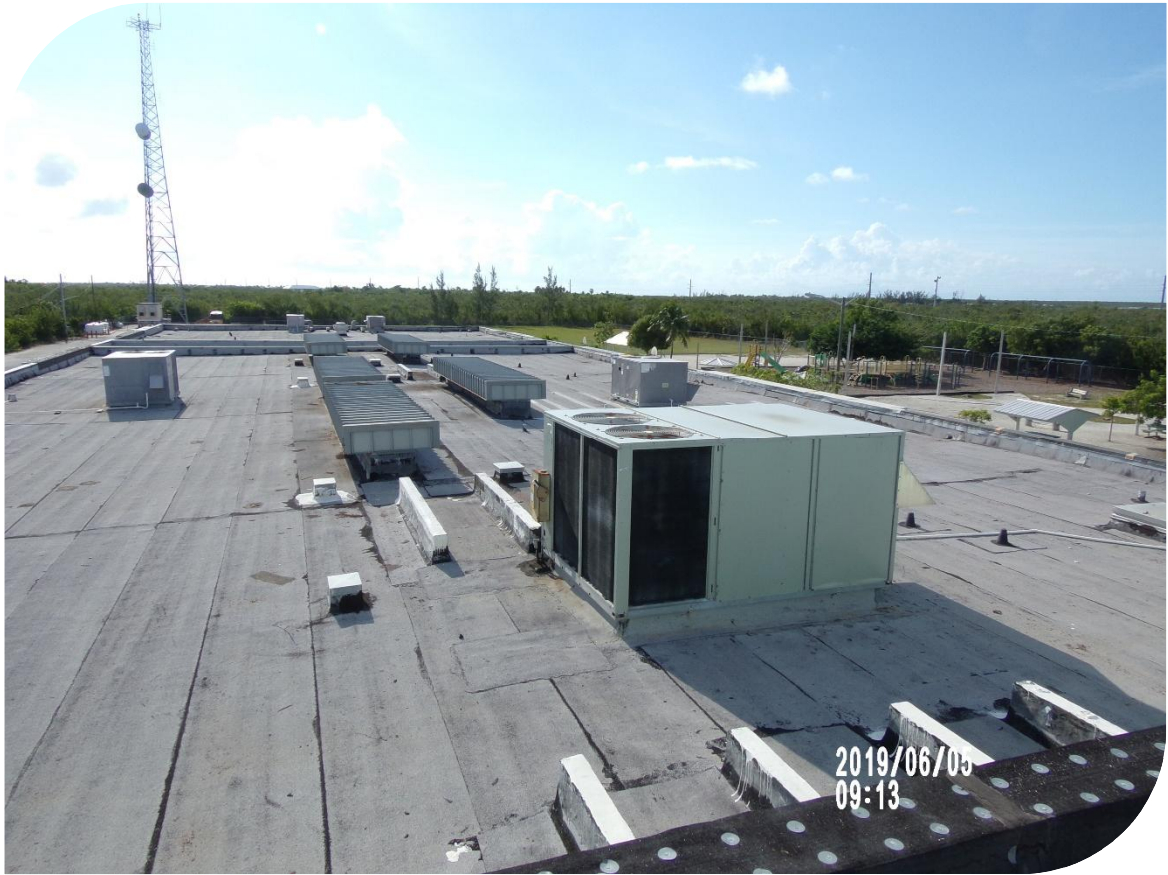
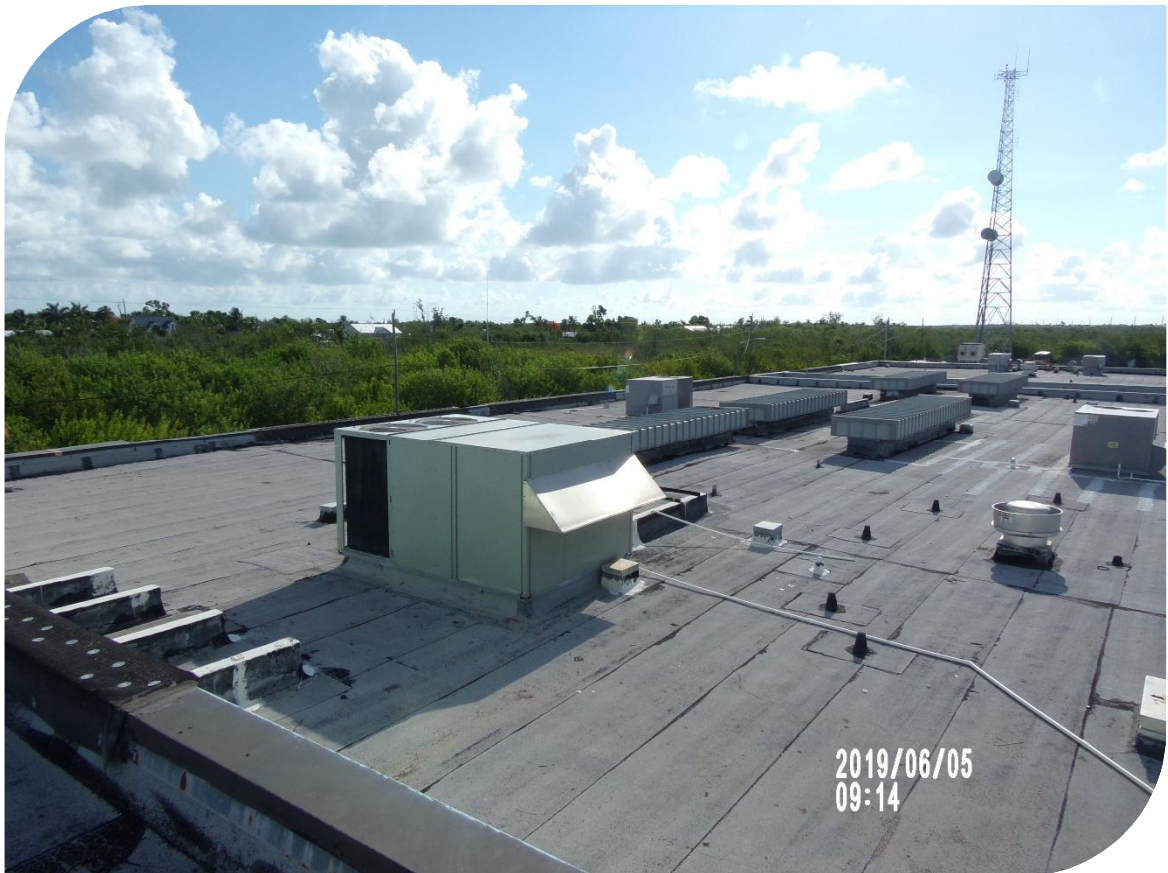
Roof & flashing deteriorated

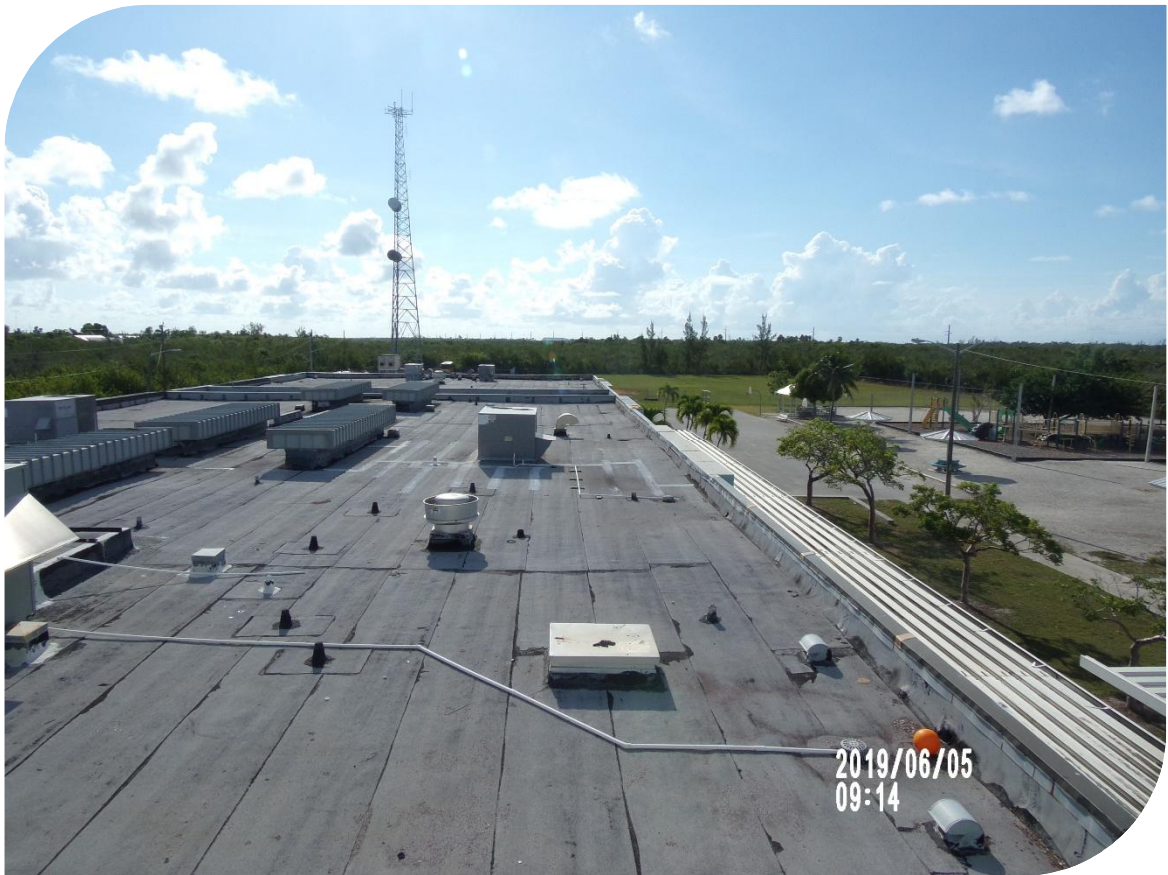
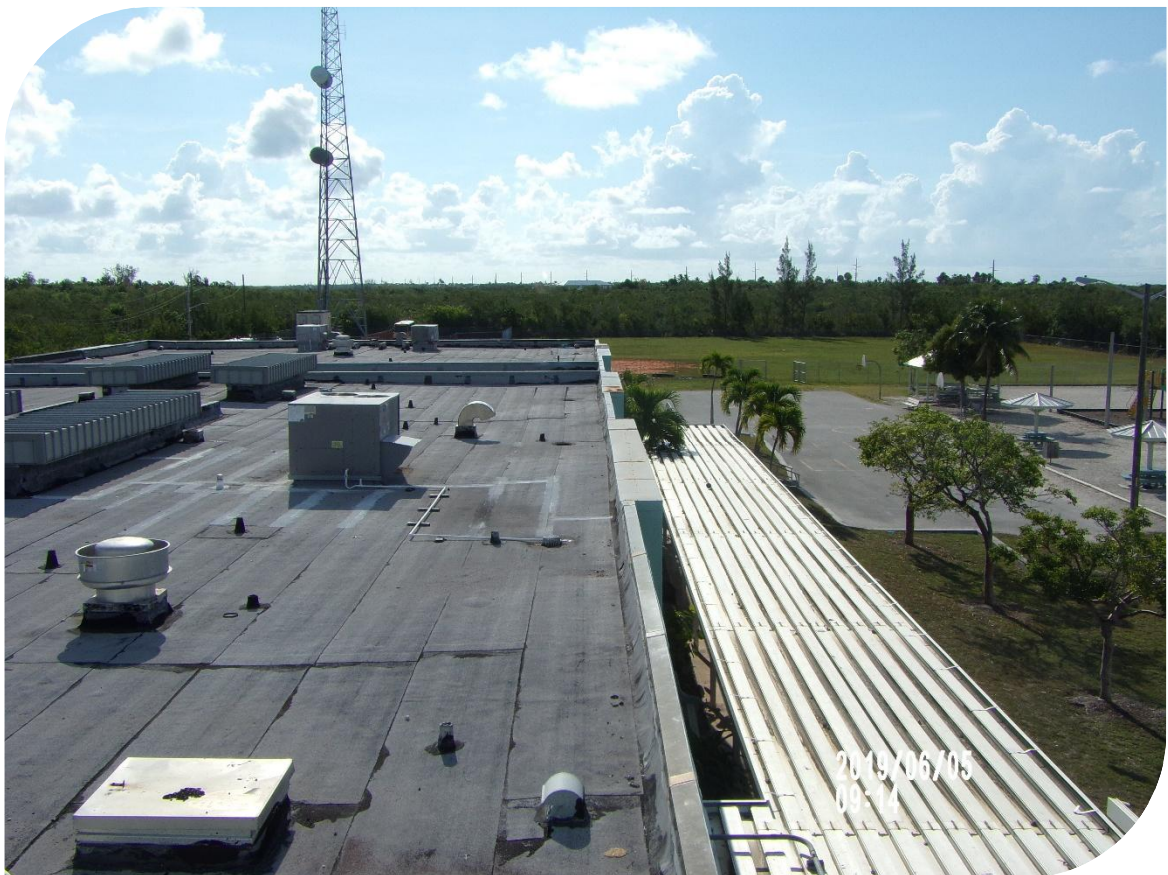
Roof replacement needed

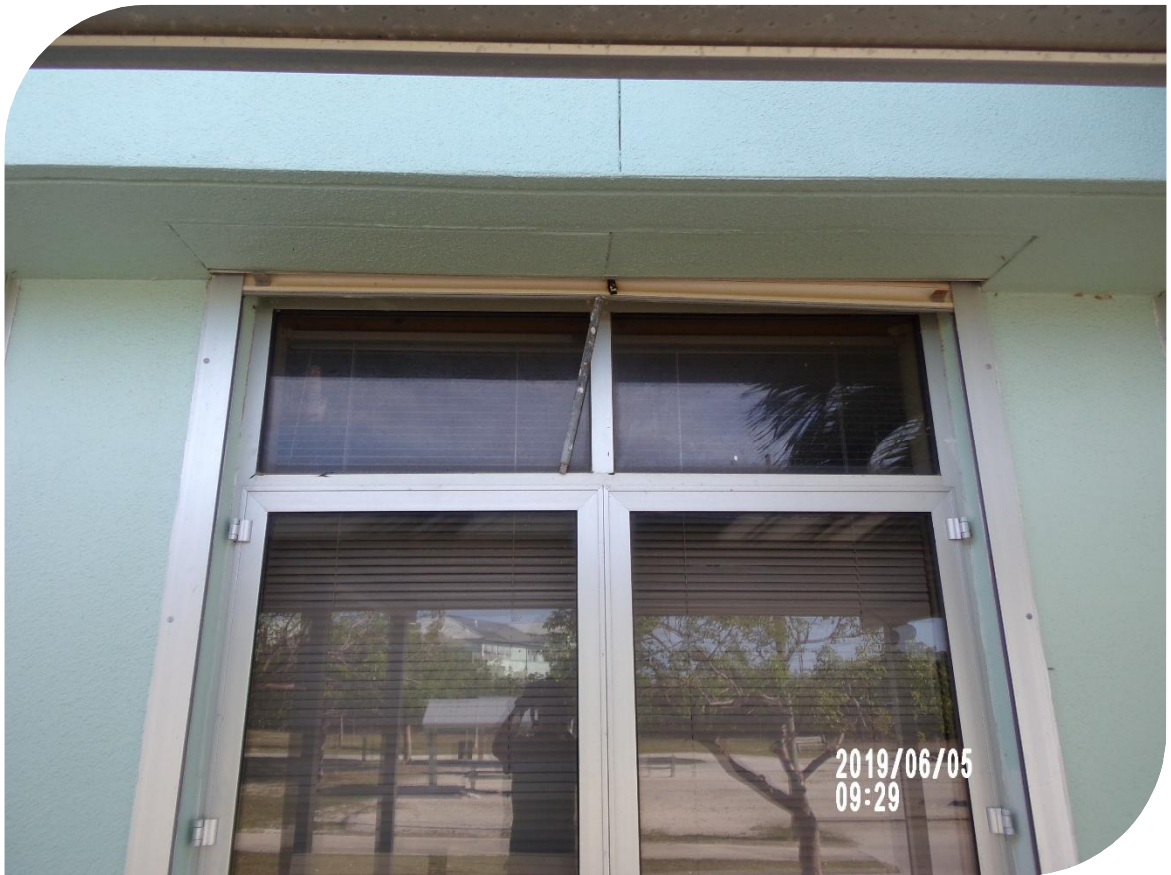
Flashing loose

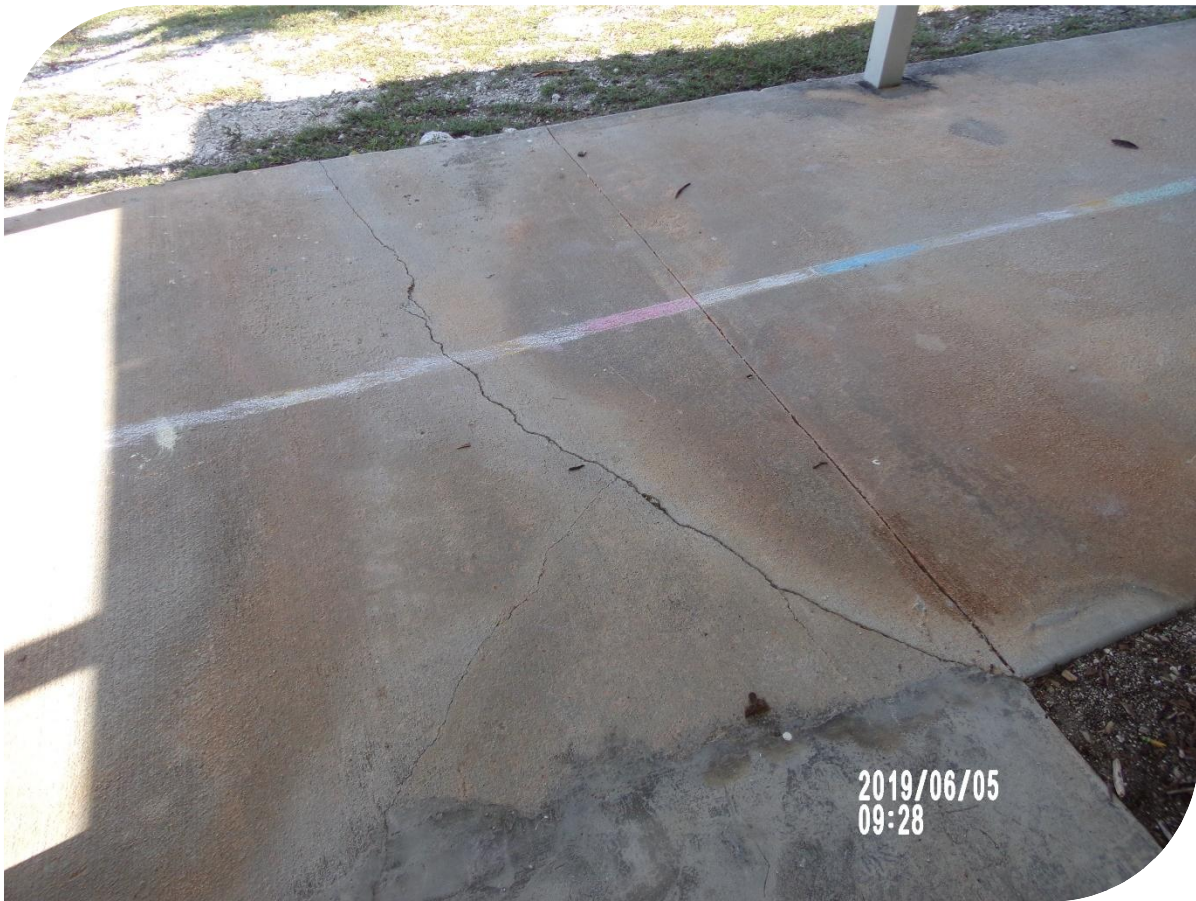
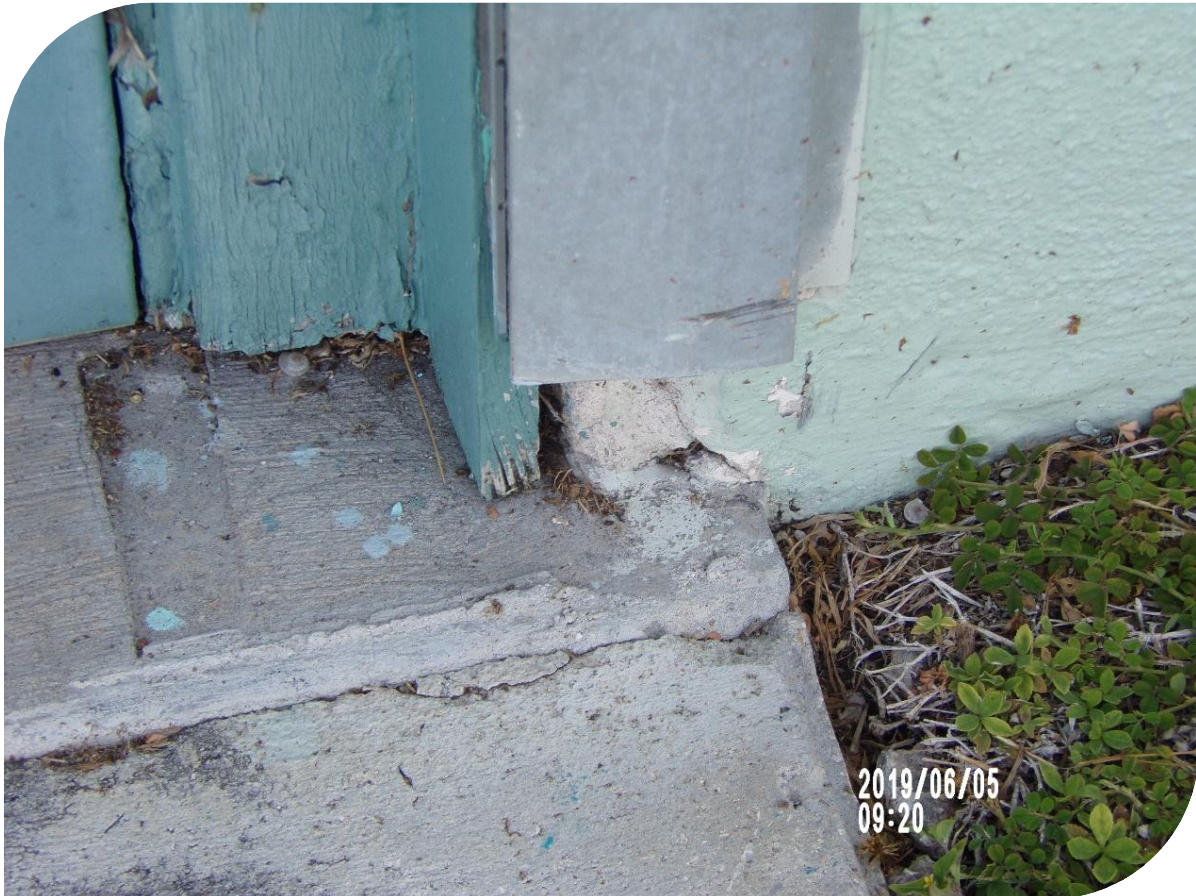
Cracks in slab

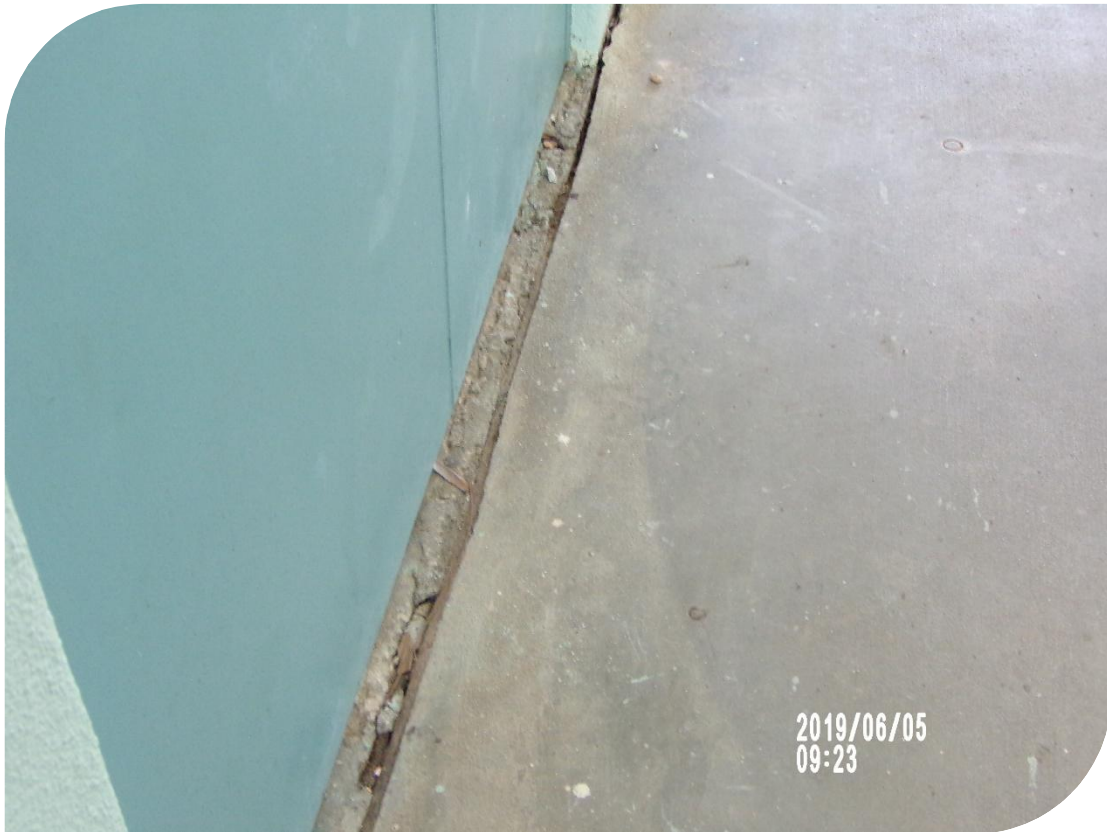
Cracked concrete and degenerating wooden jambs

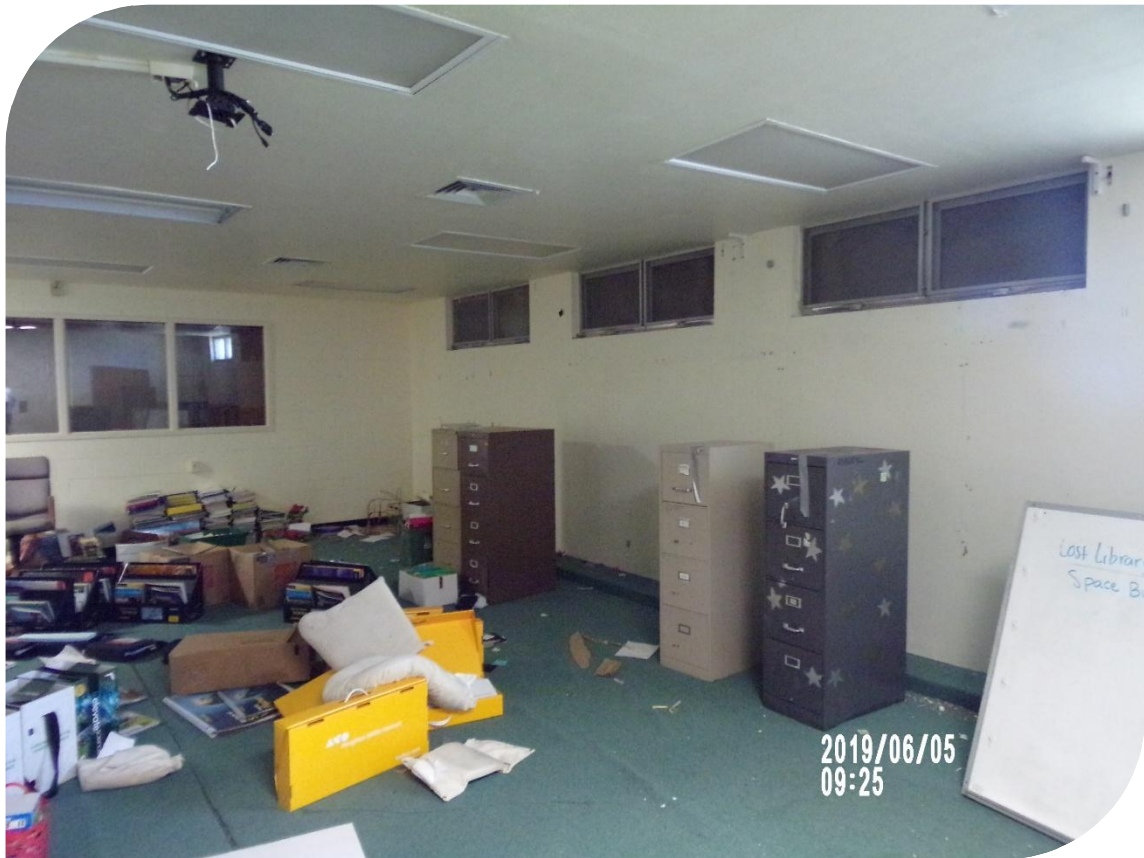
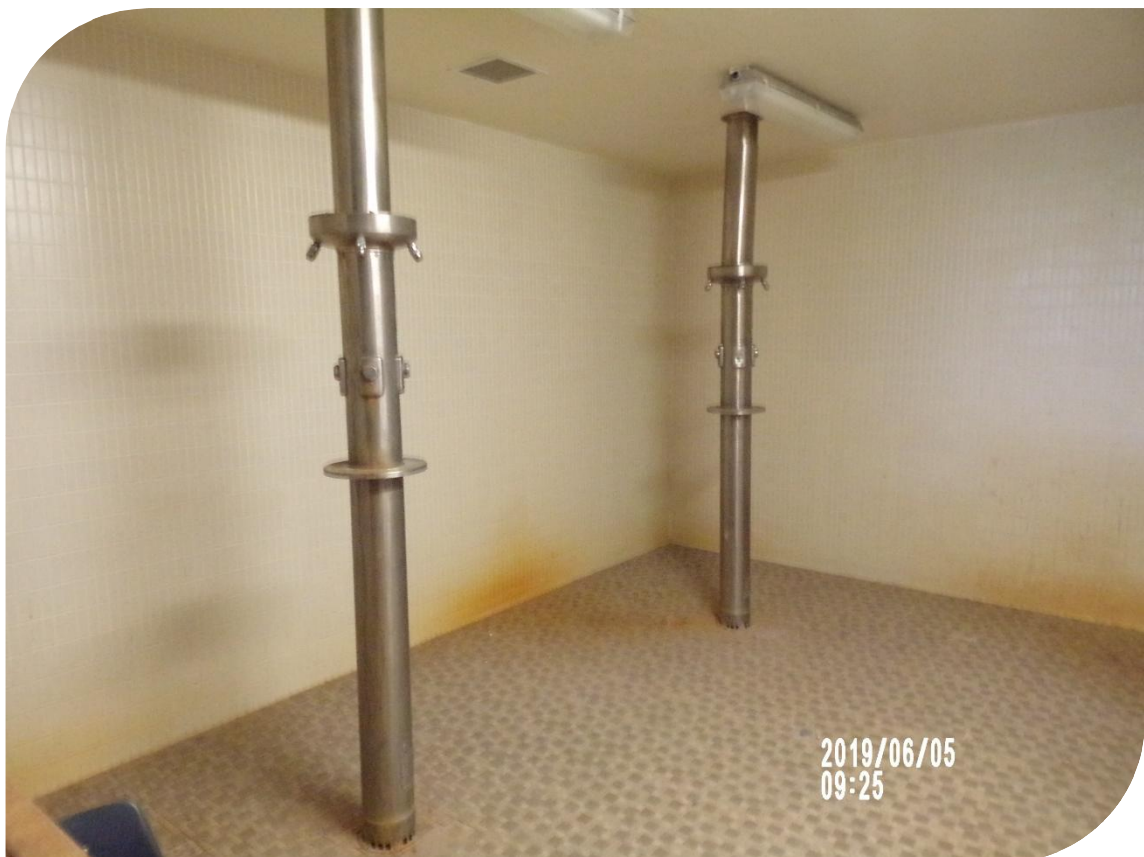
Termites and moisture decay

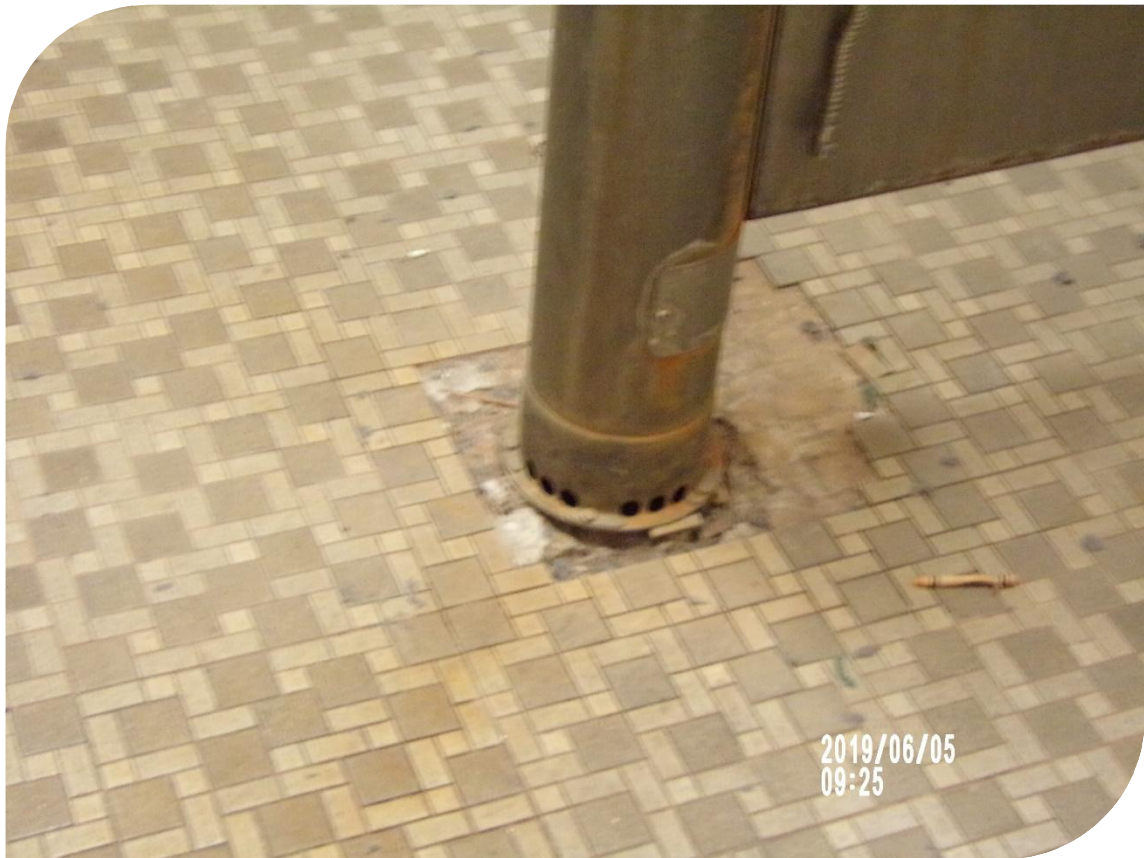
Disrepair of unoccupied buildings

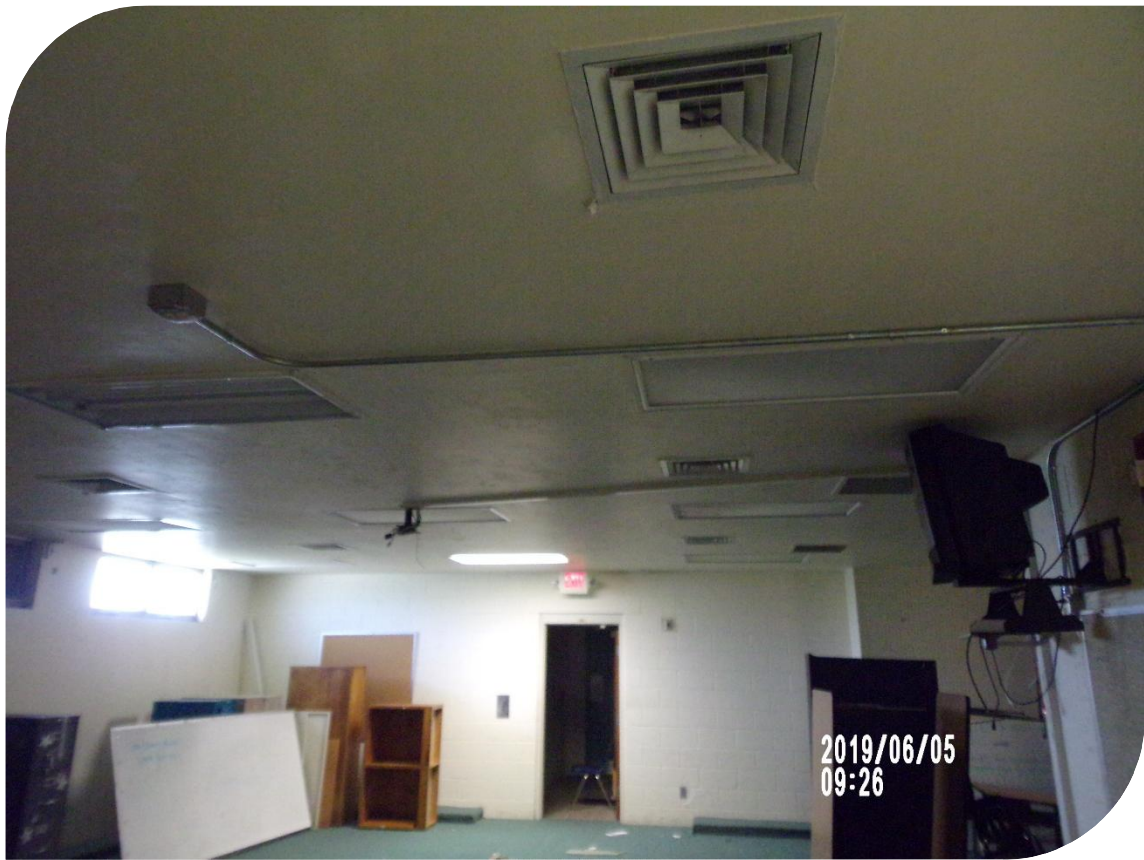
Wall moisture intrusion

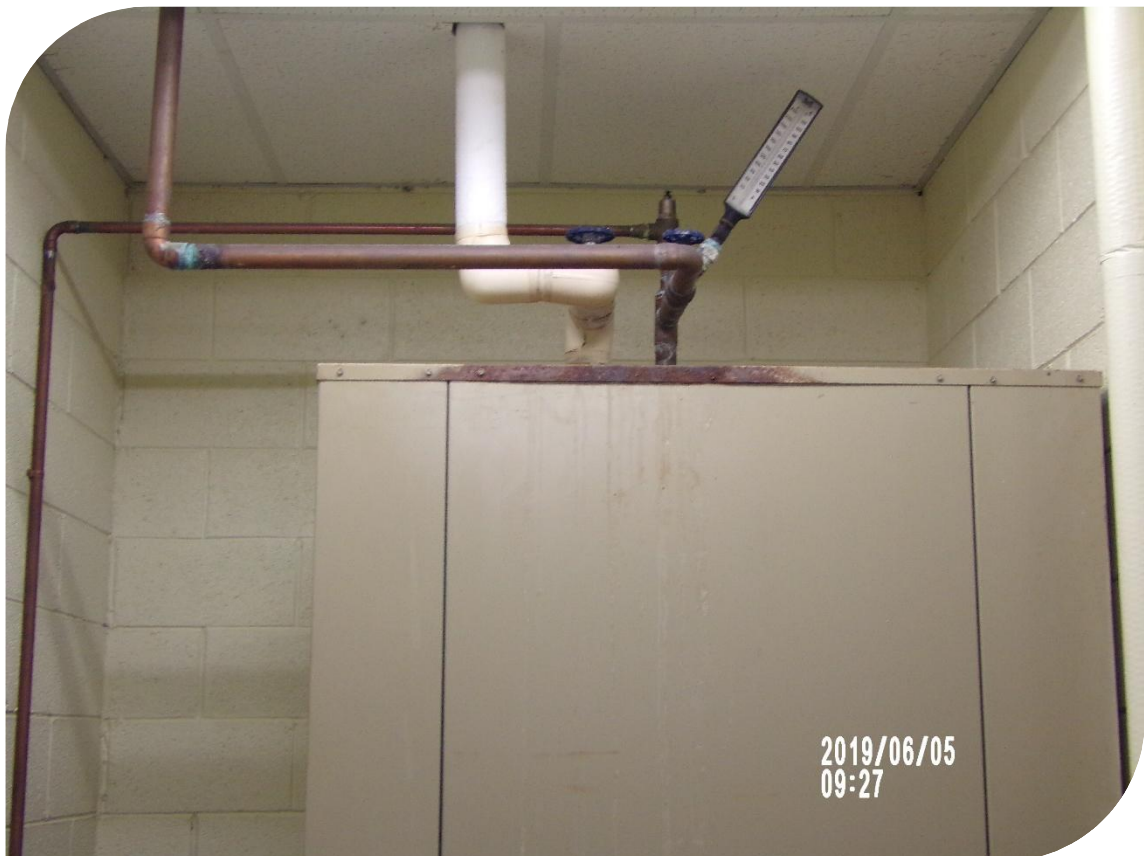
General interior condition

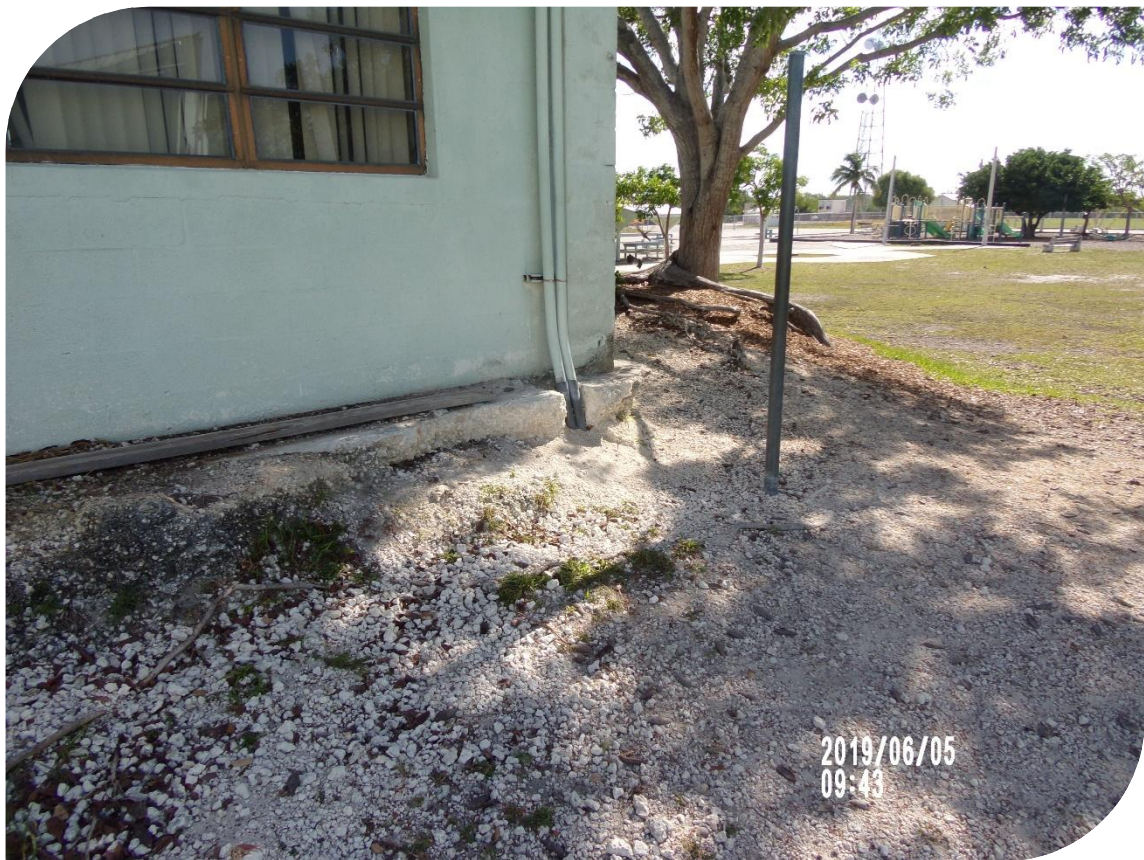
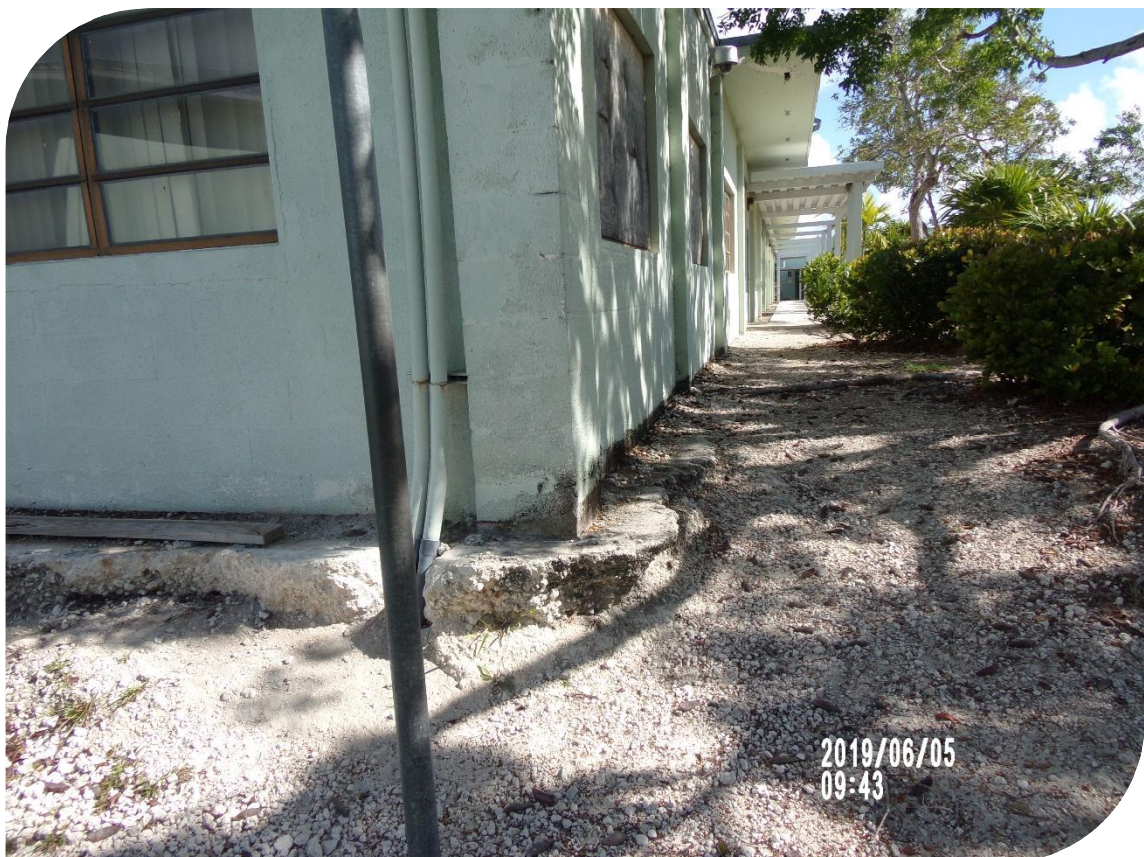
Ground around foundation washed away

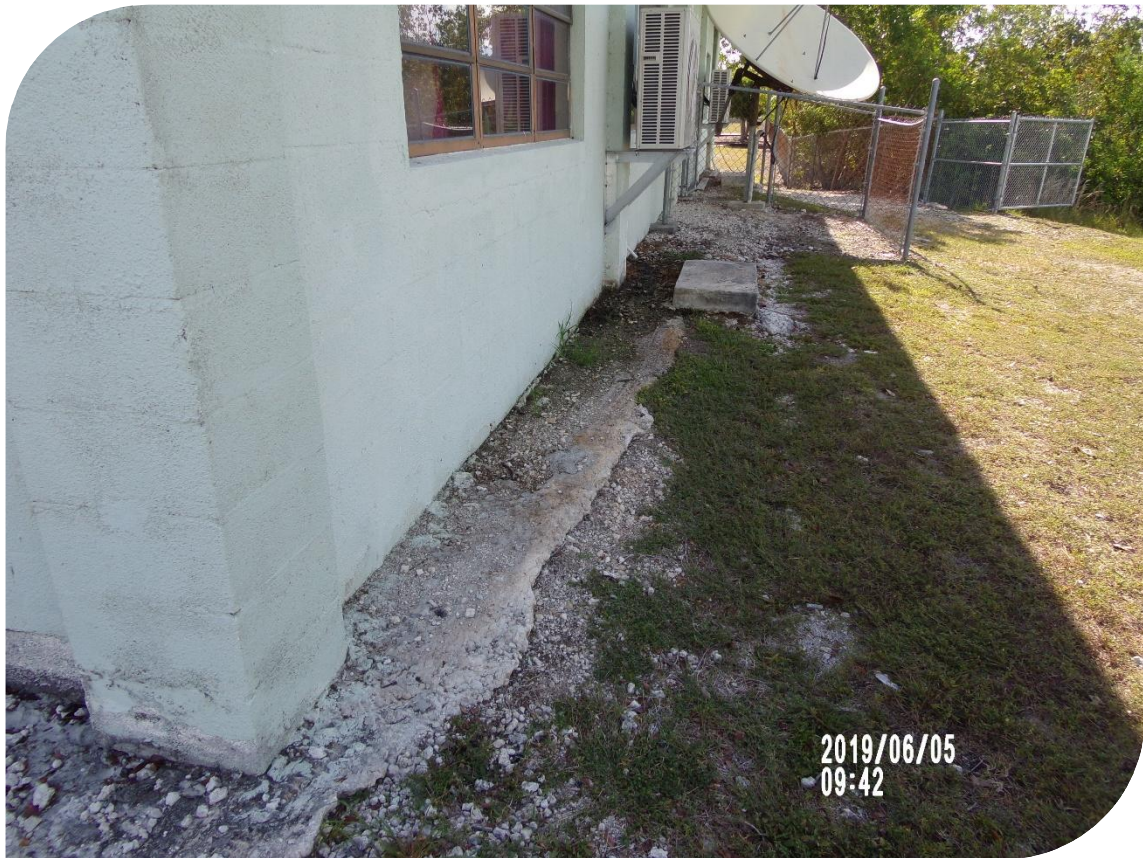
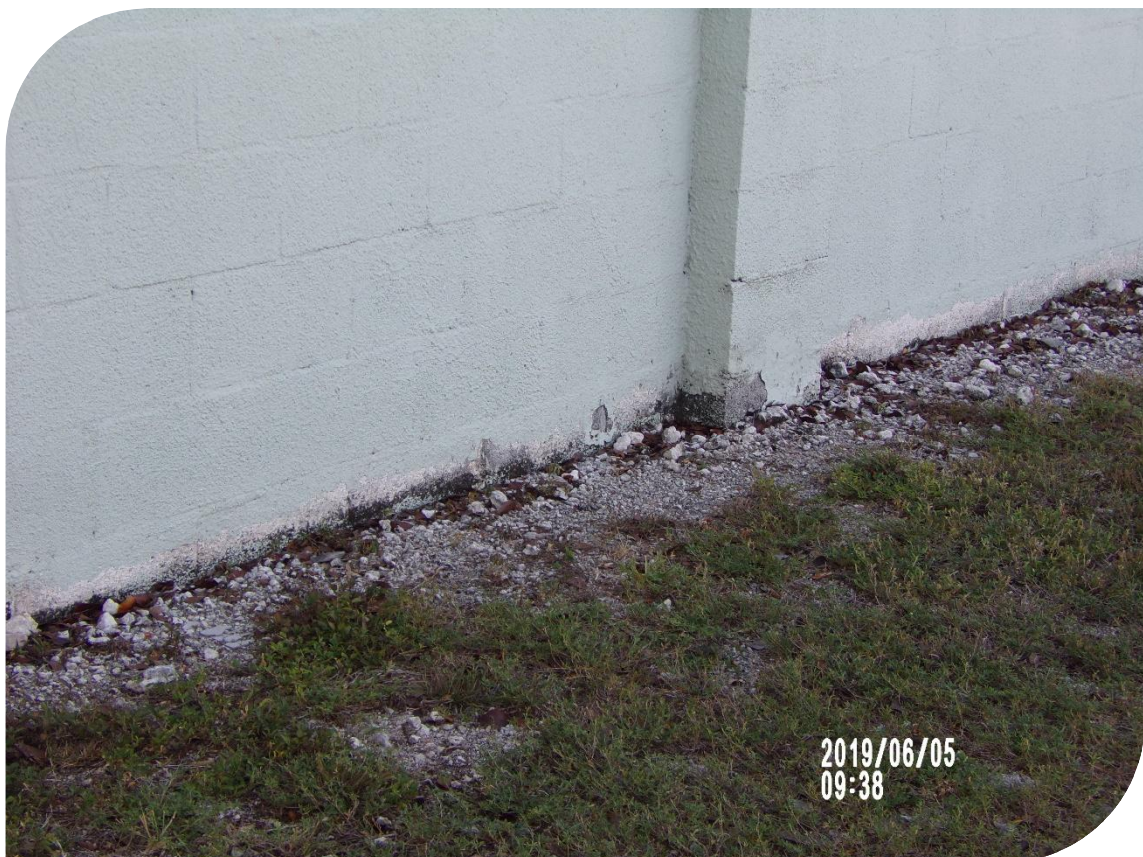
Ground around foundation washed away
