BUILDING REPLACEMENT STUDY

SUGARLOAF SCHOOL

SUGARLOAF KEY, FLORIDA

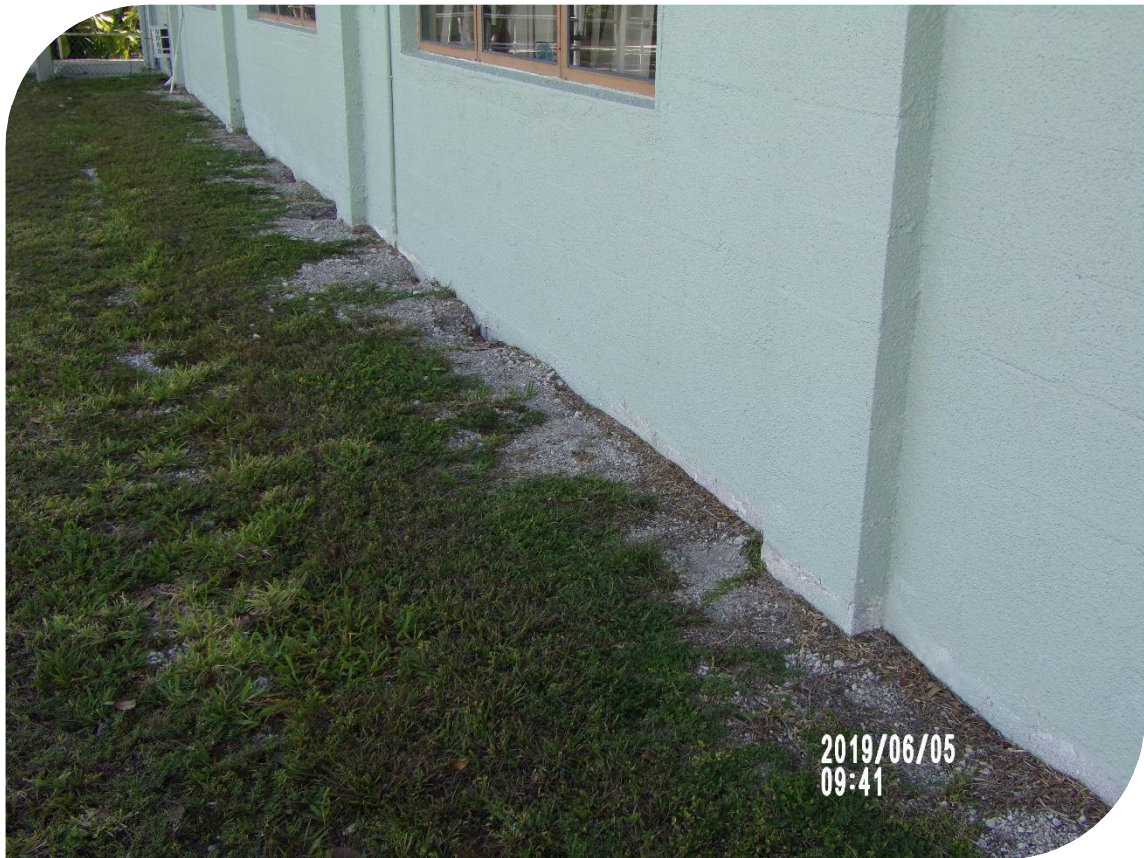
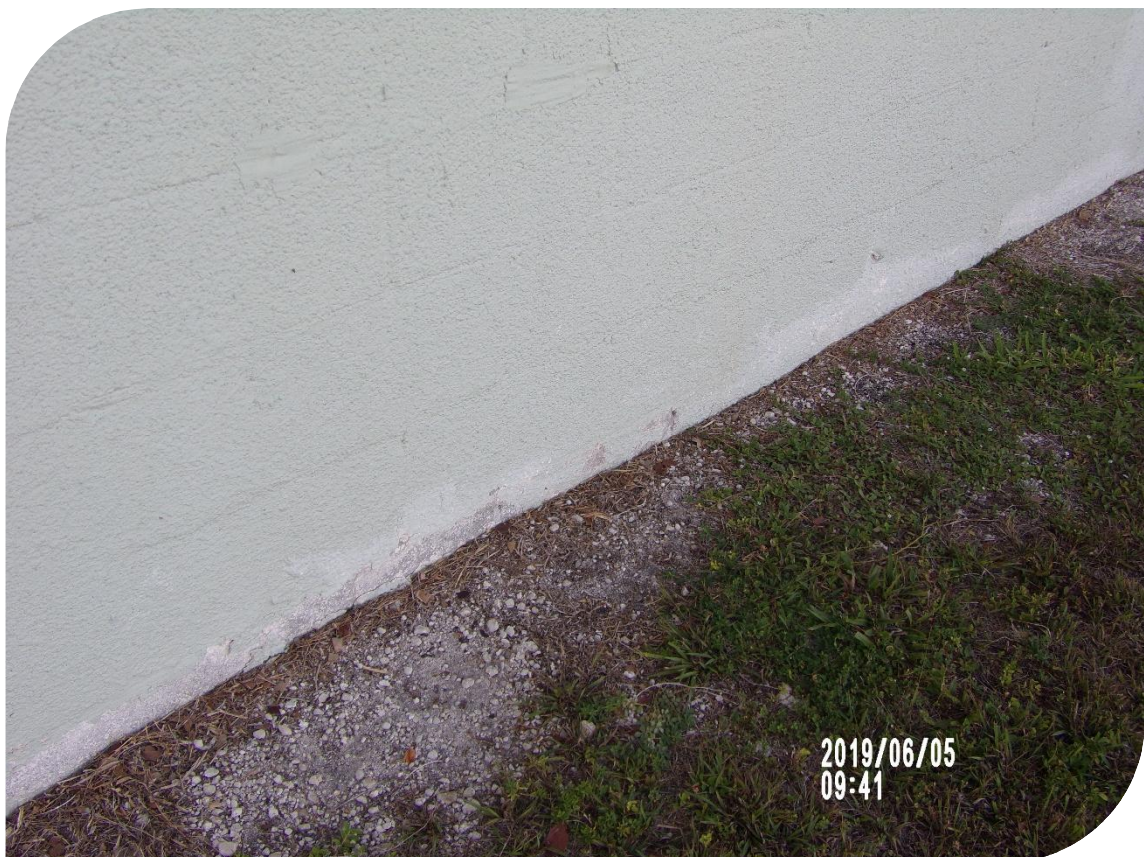
Ground around foundation washed away

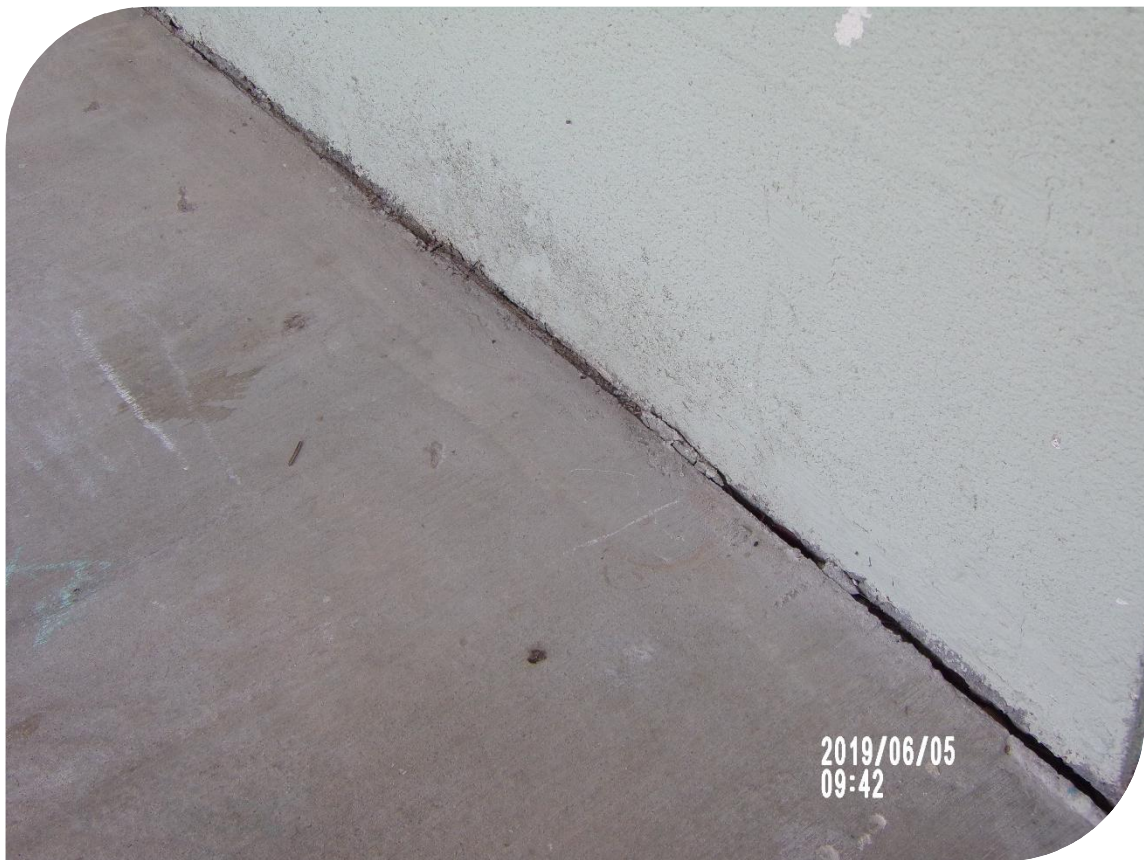
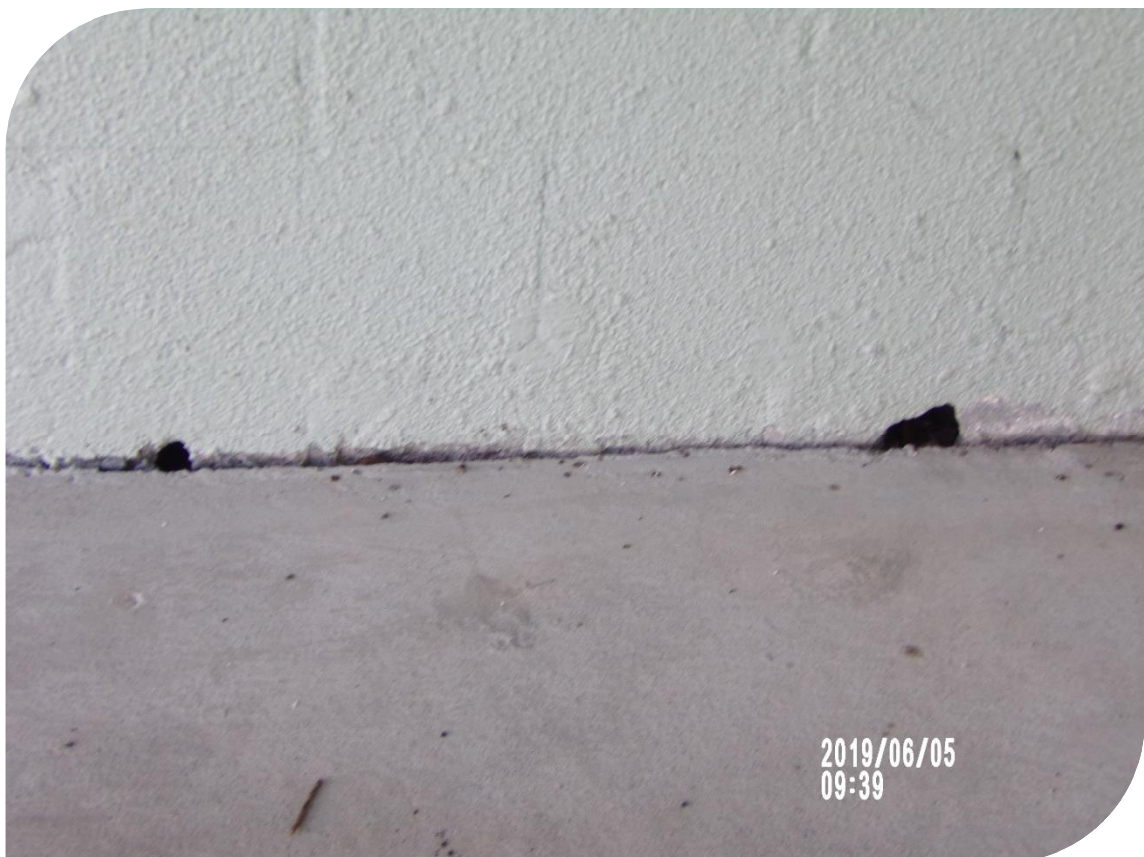
Sidewalk detached from foundation

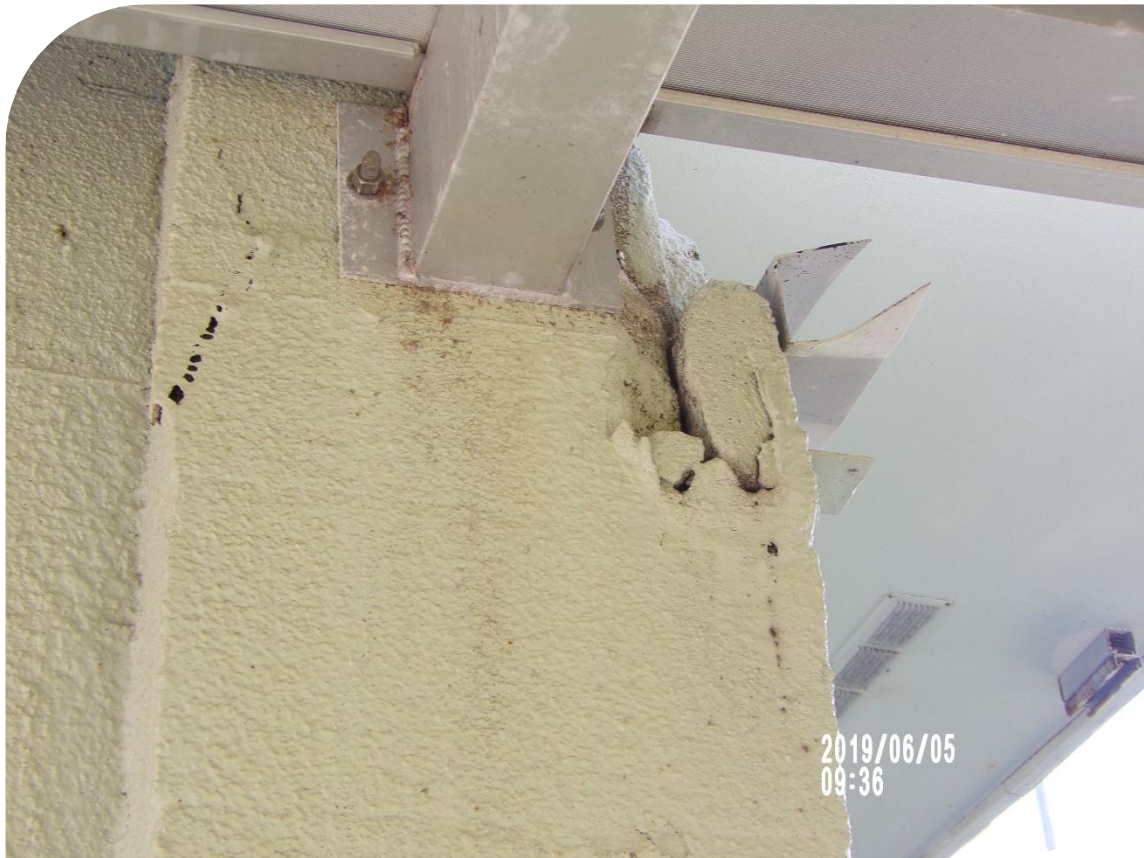
Crumbling concrete

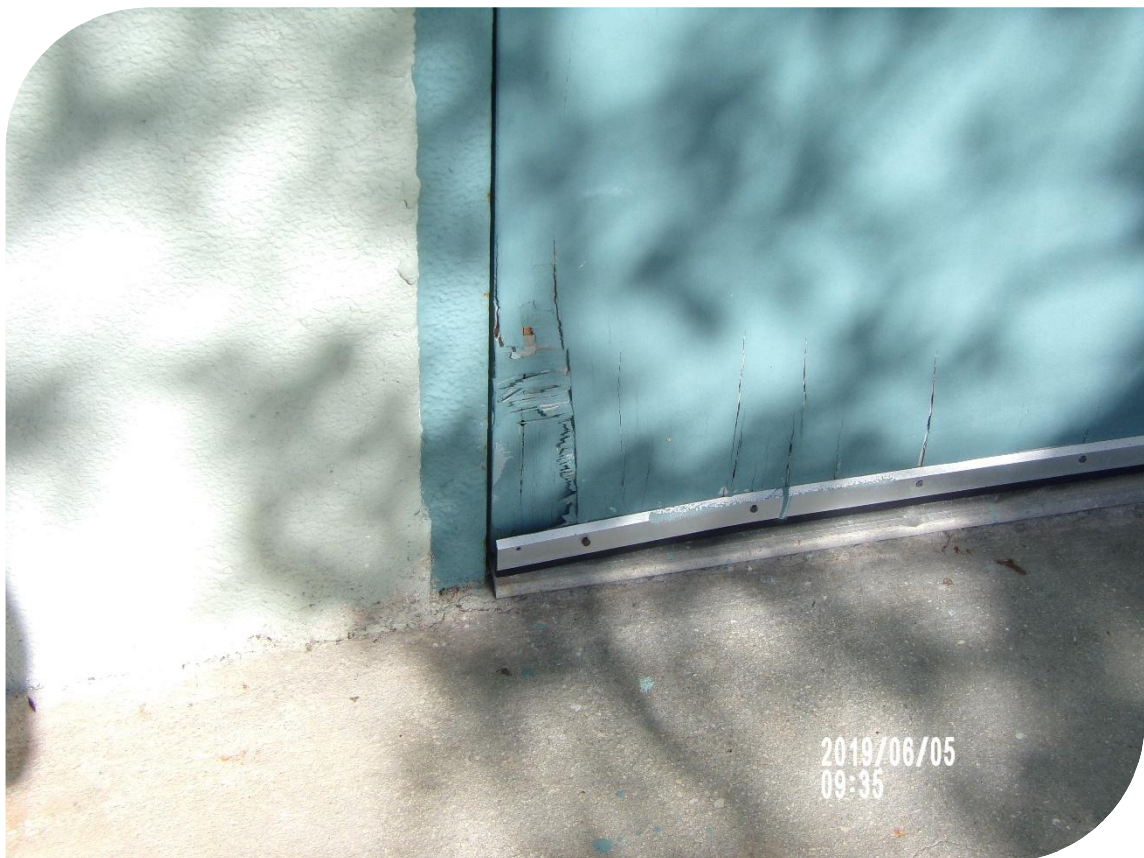
Wood doors with water damage

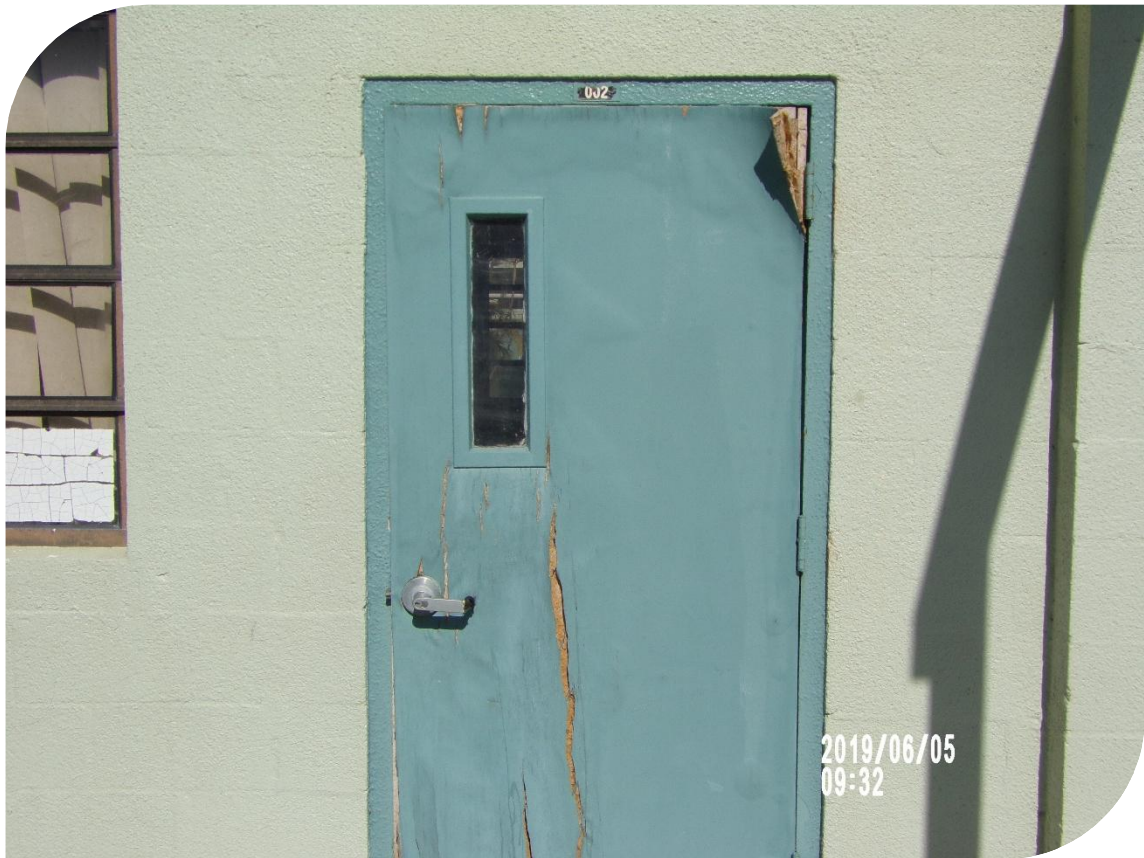
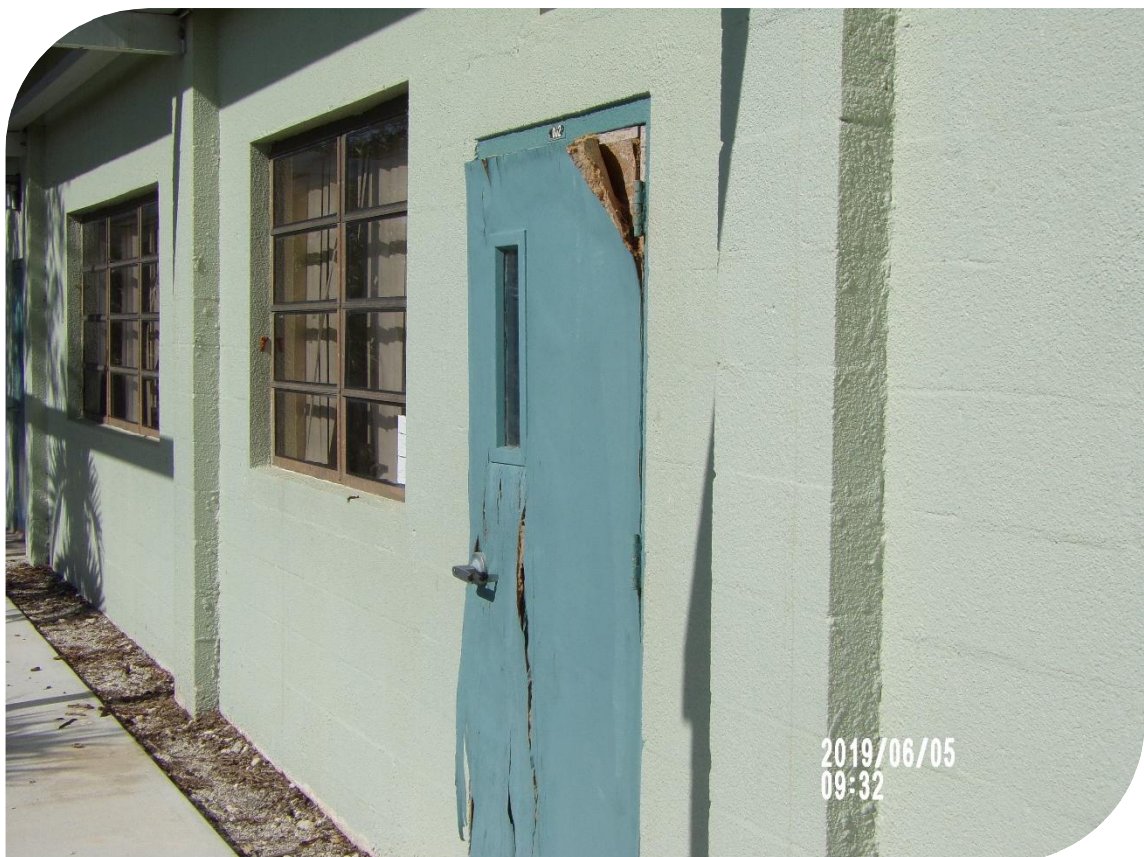
Deteriorated wood doors

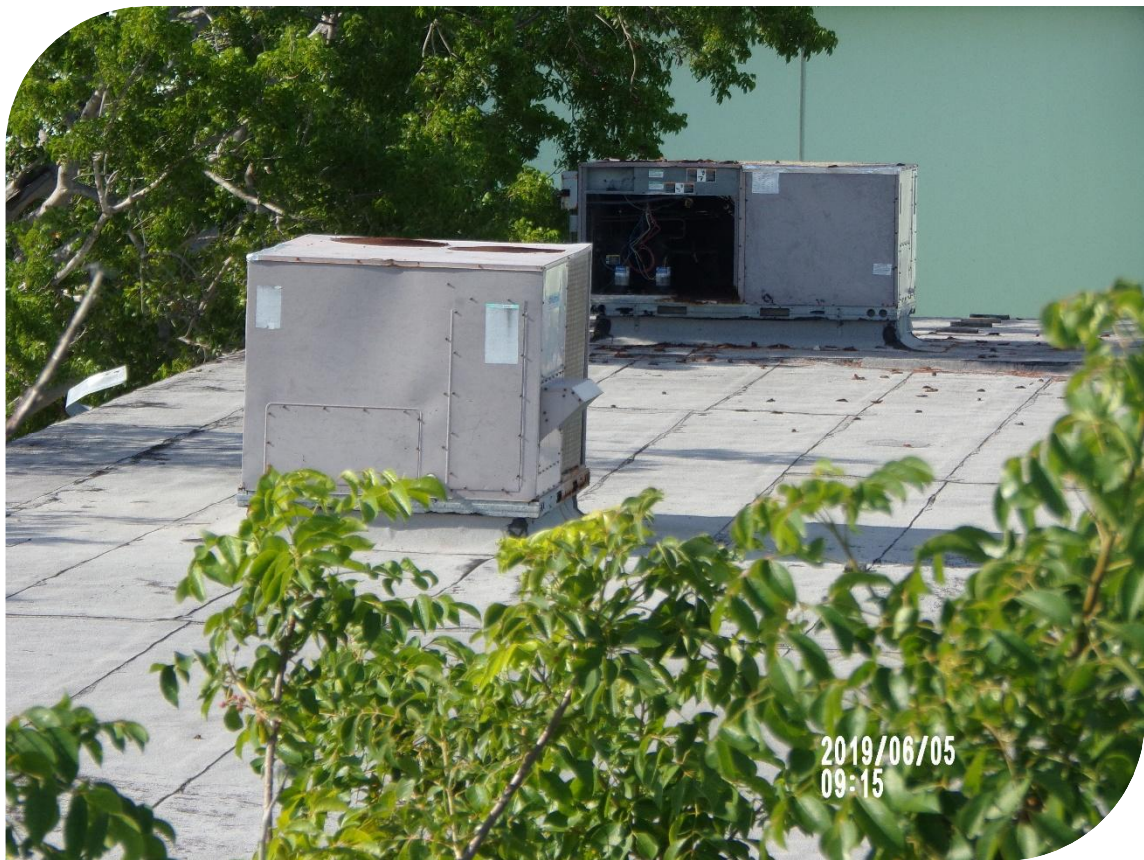
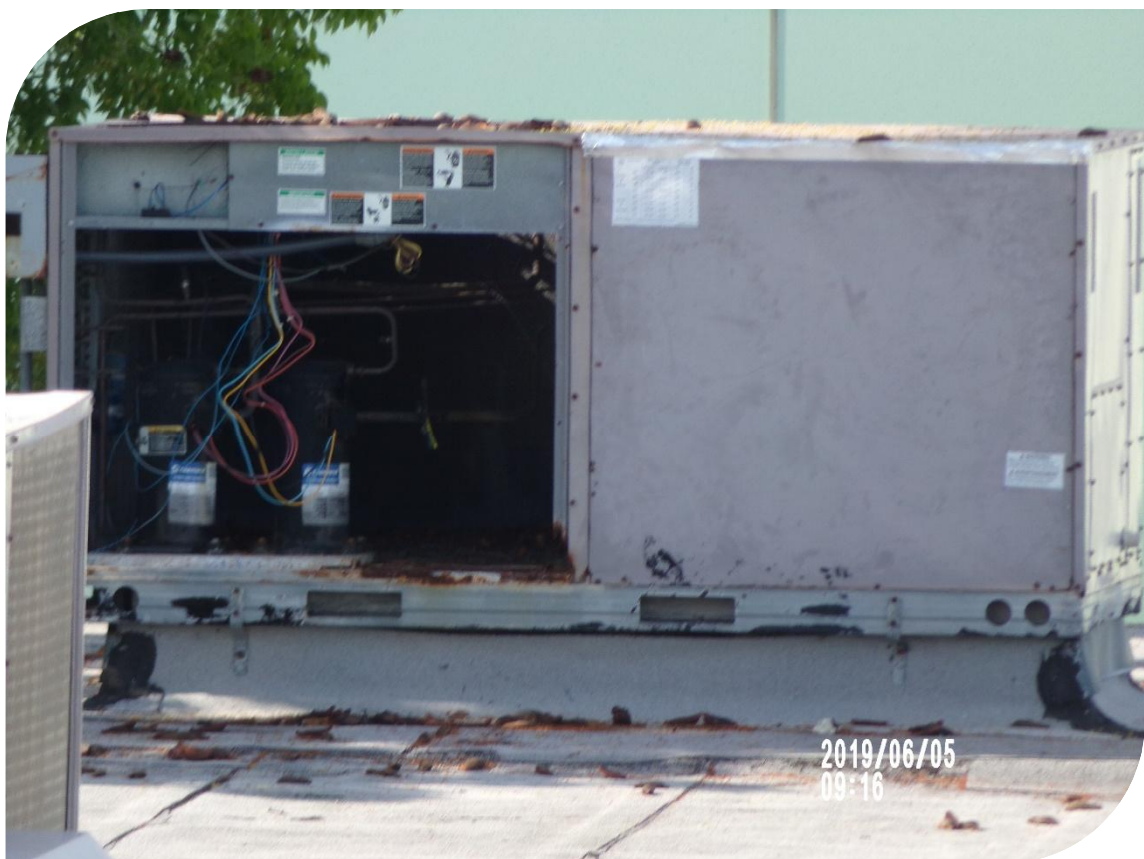
Obsolete rooftop equipment

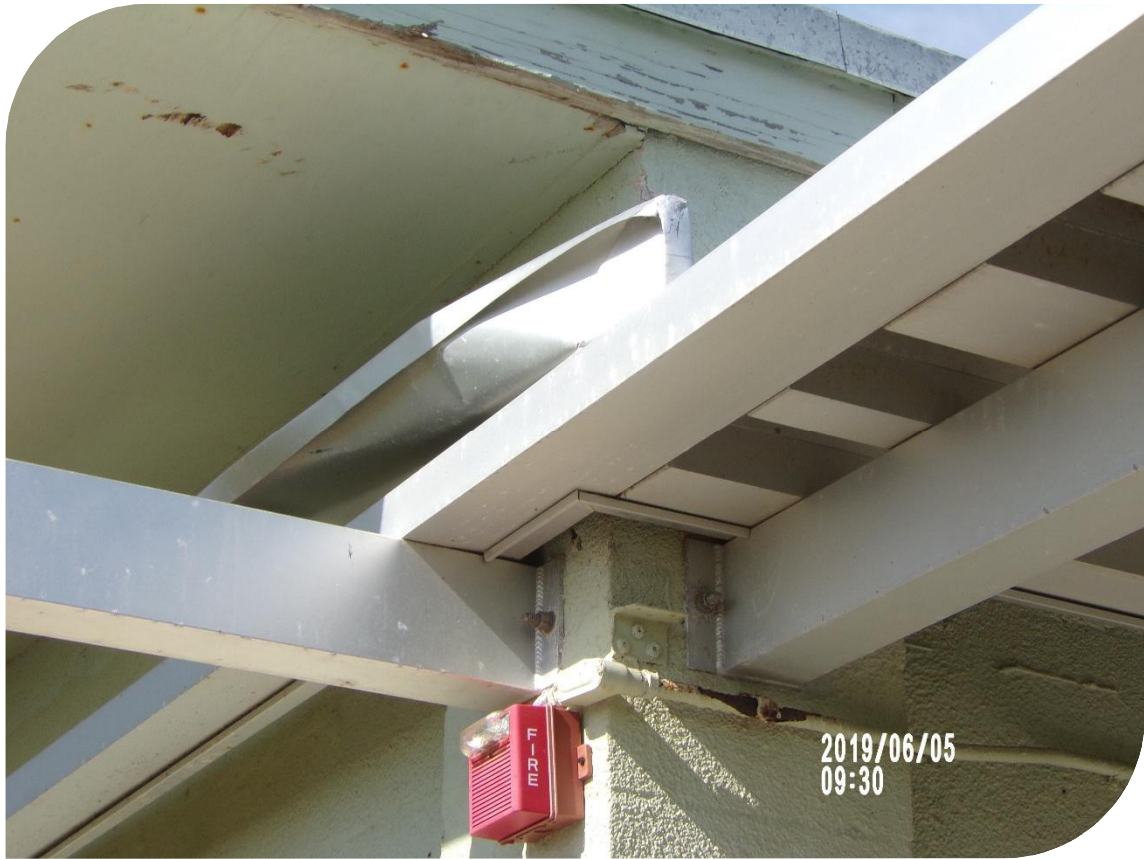
Canopy Damage

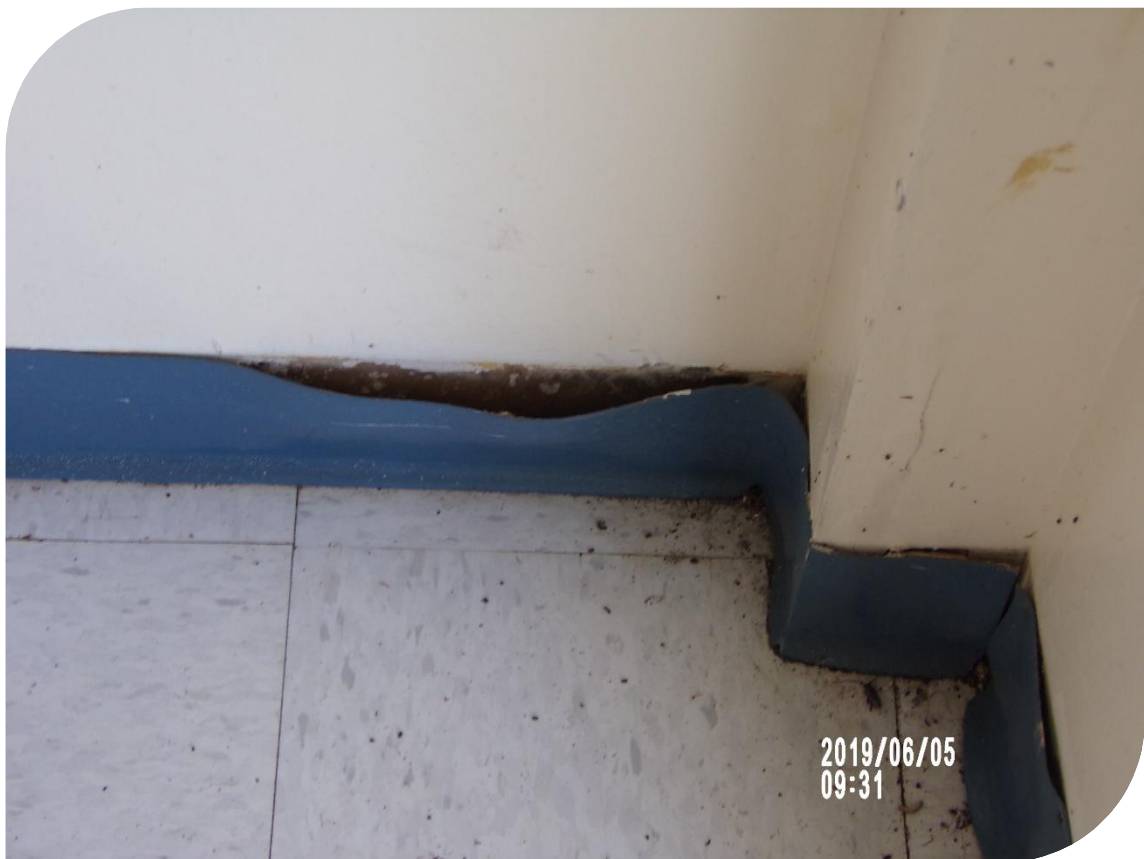
Moisture intrusion at base

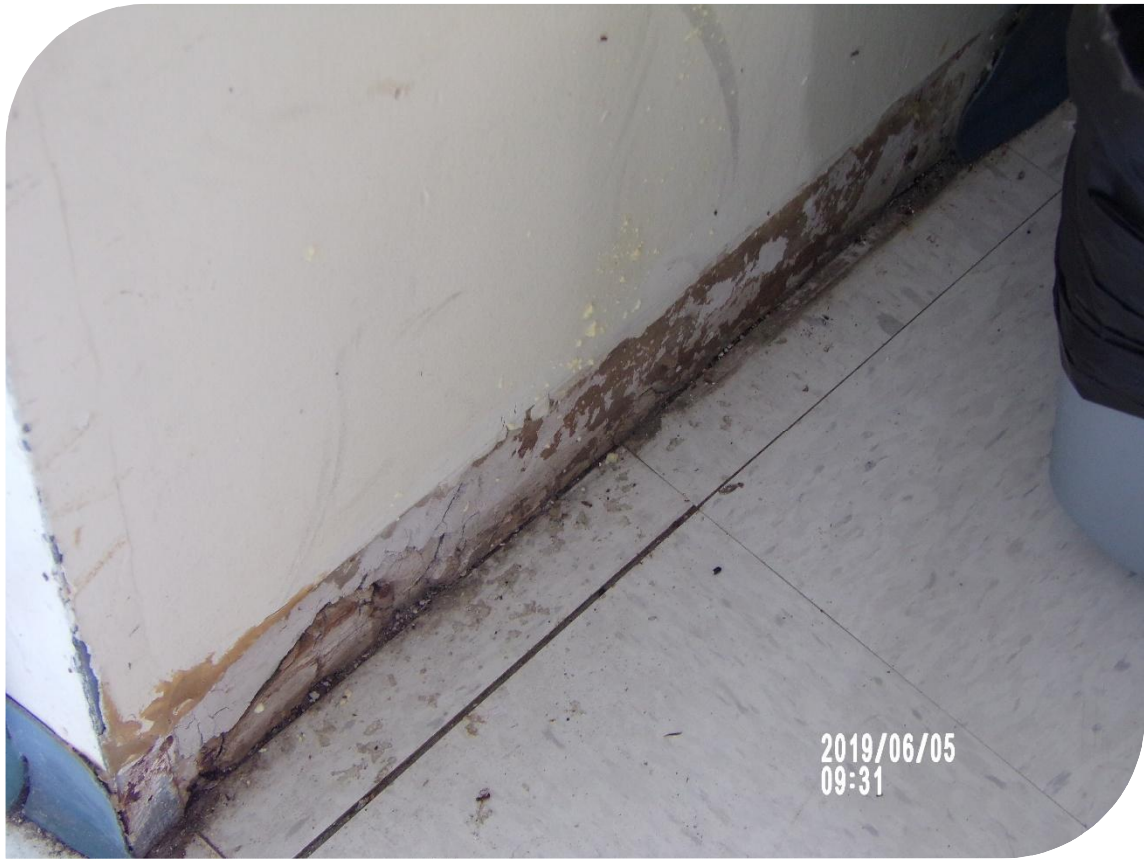
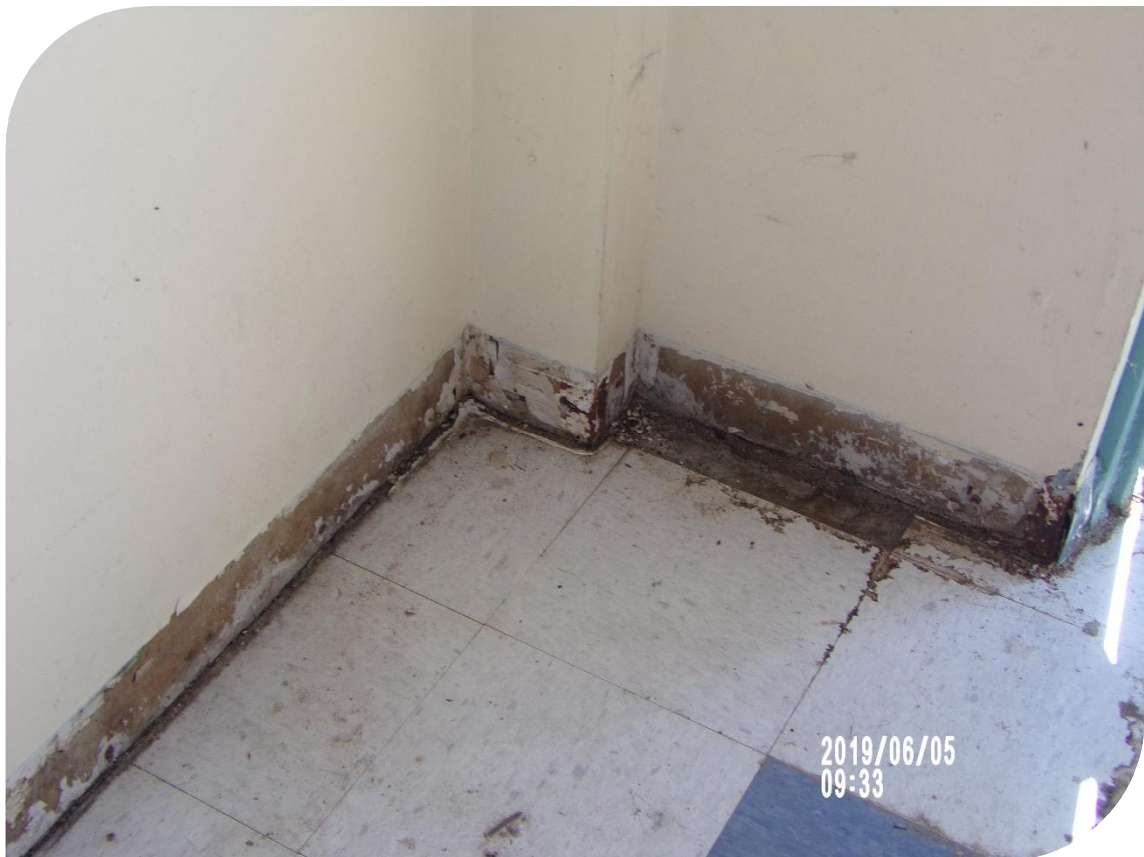
Moisture intrusion at base

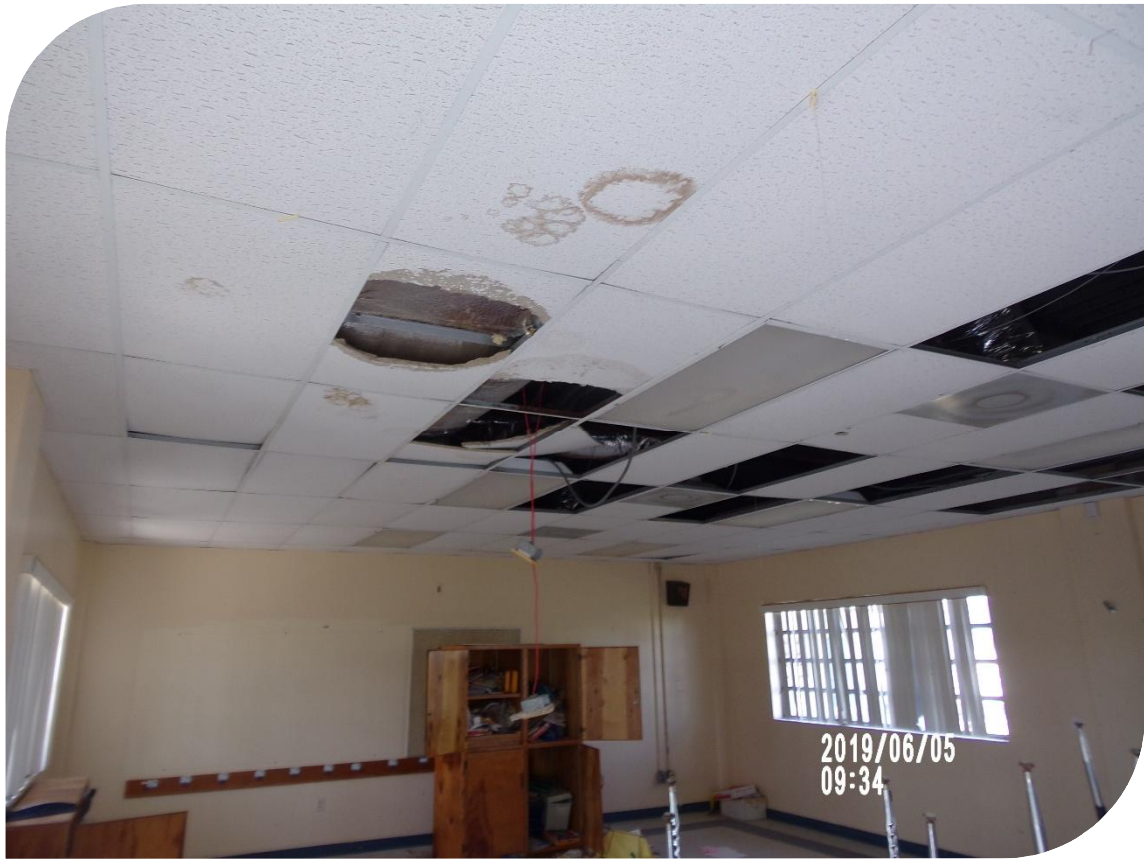
Evidence of leaking roof

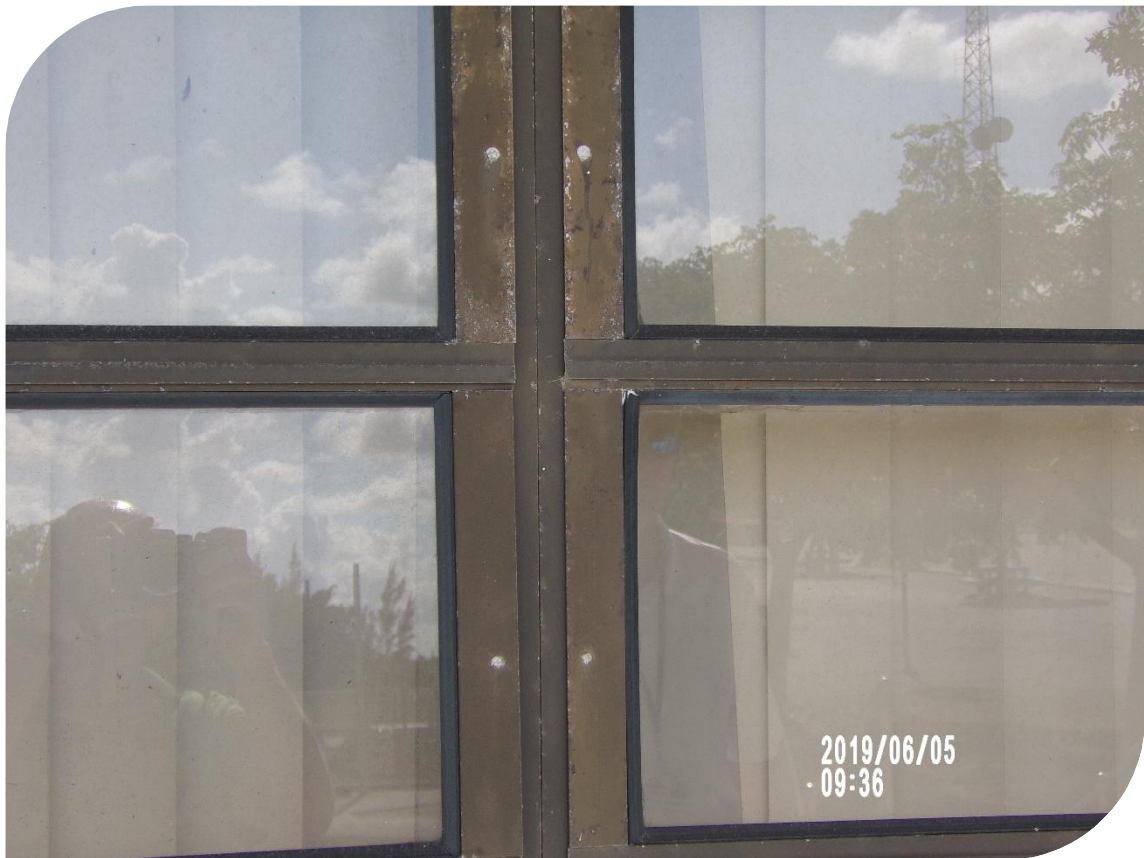
Non-rated windows with gaps that allow air intrusion

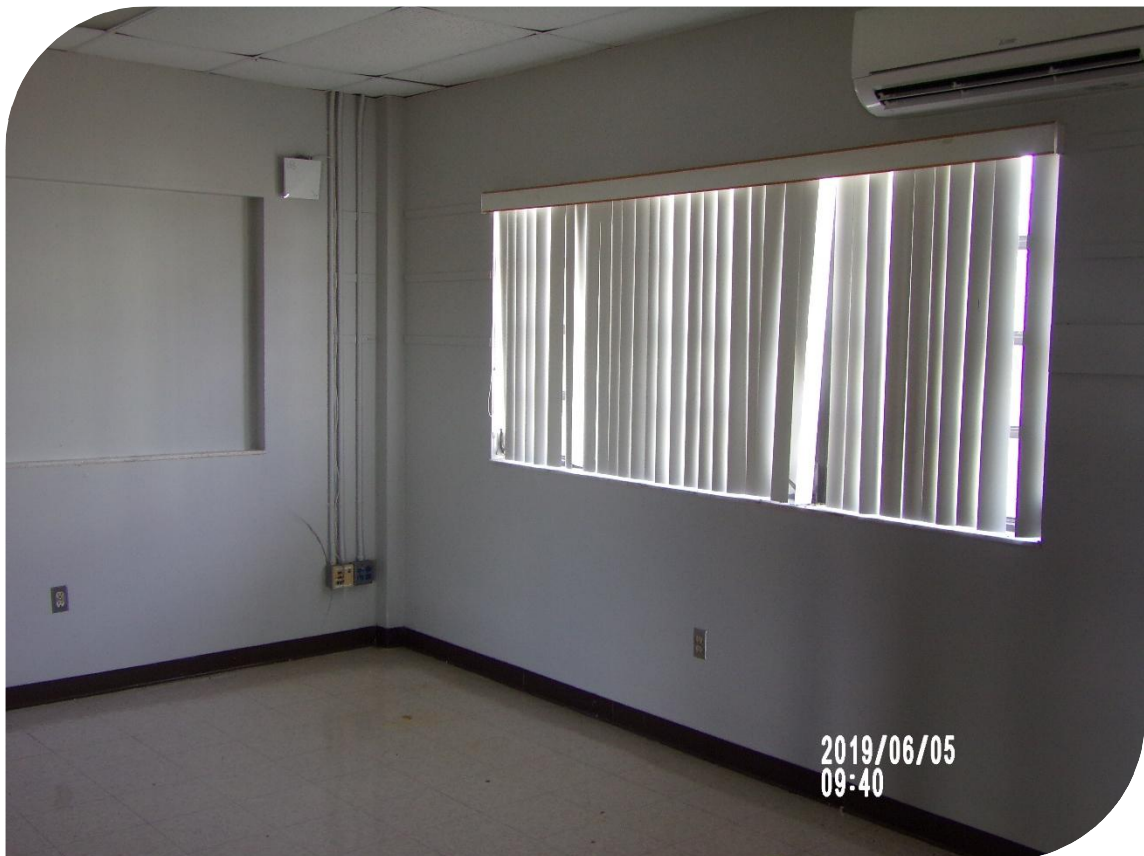
Moisture Intrusion

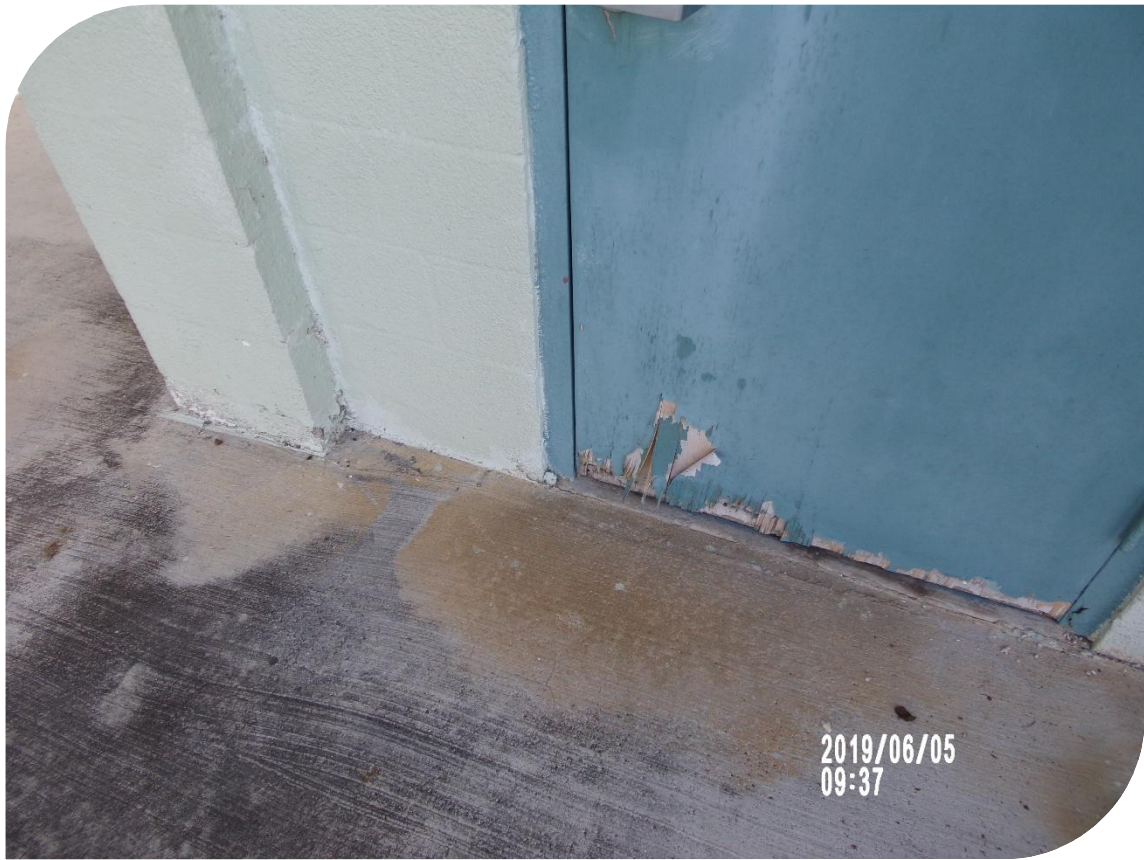
Wood doors with water damage
