BUILDING REPLACEMENT STUDY

SUGARLOAF SCHOOL

SUGARLOAF KEY, FLORIDA

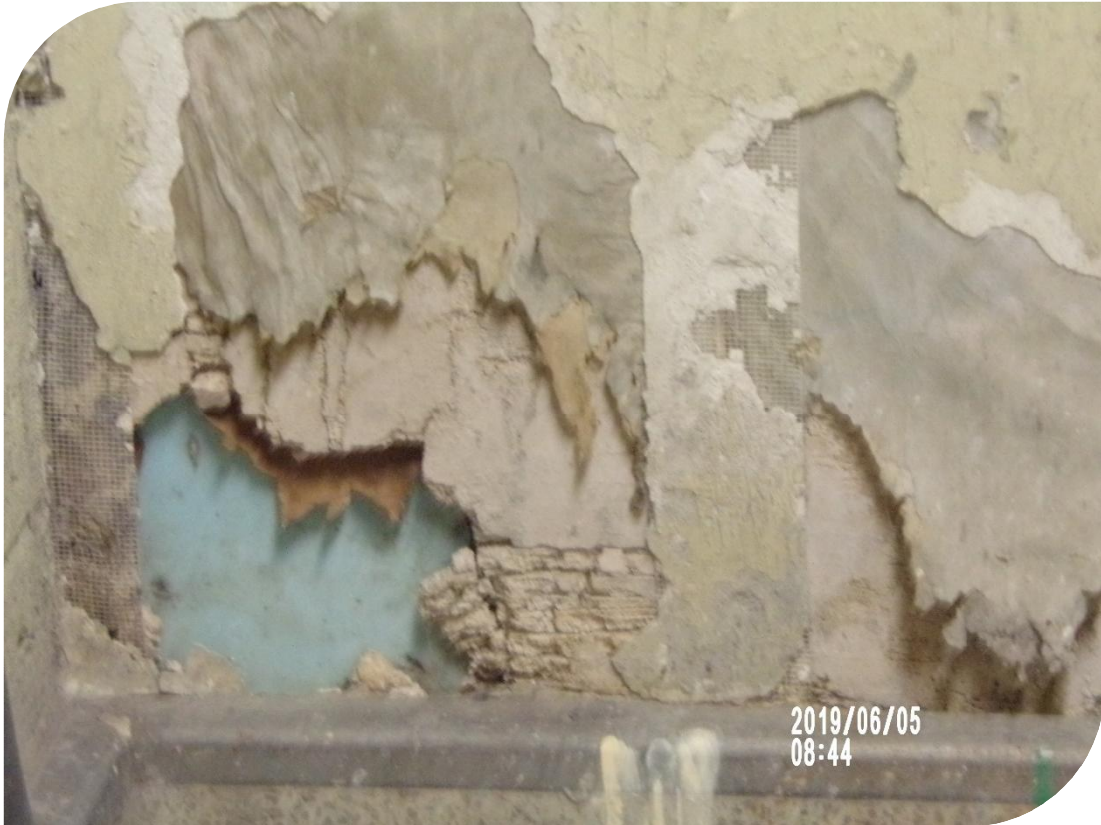
Debris from failing ceiling

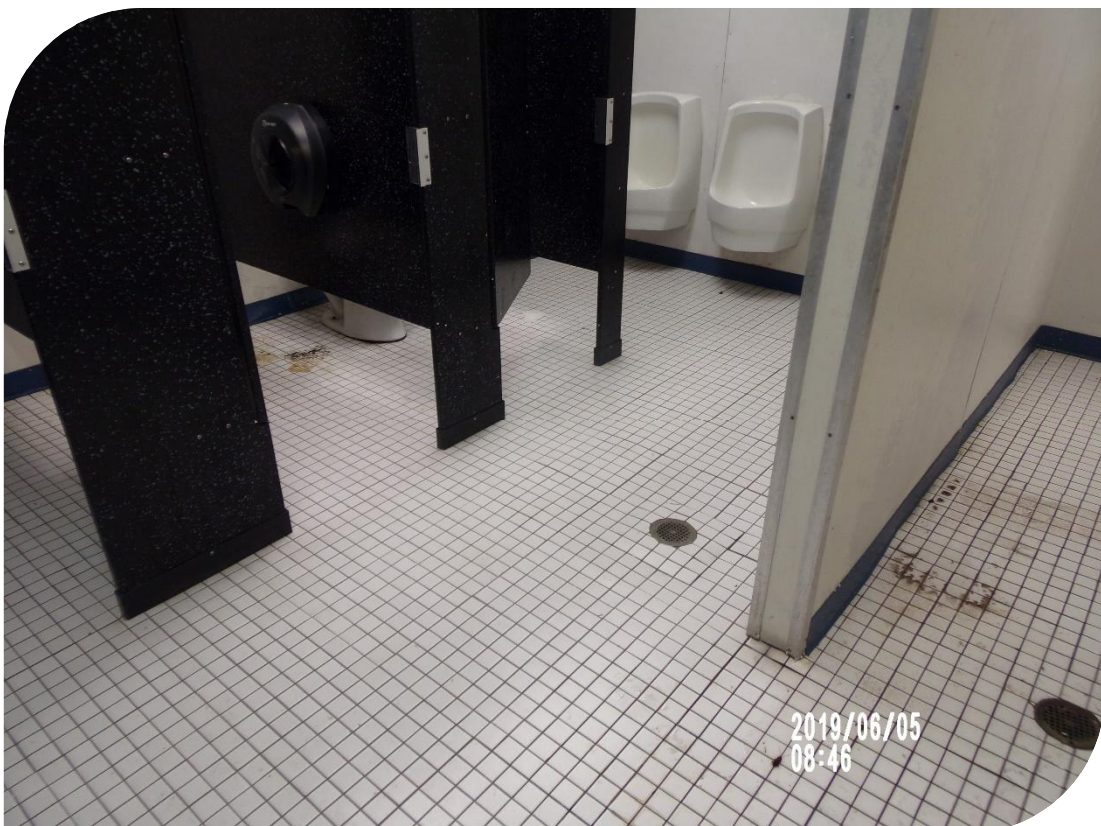
Termite and Flooding Damage

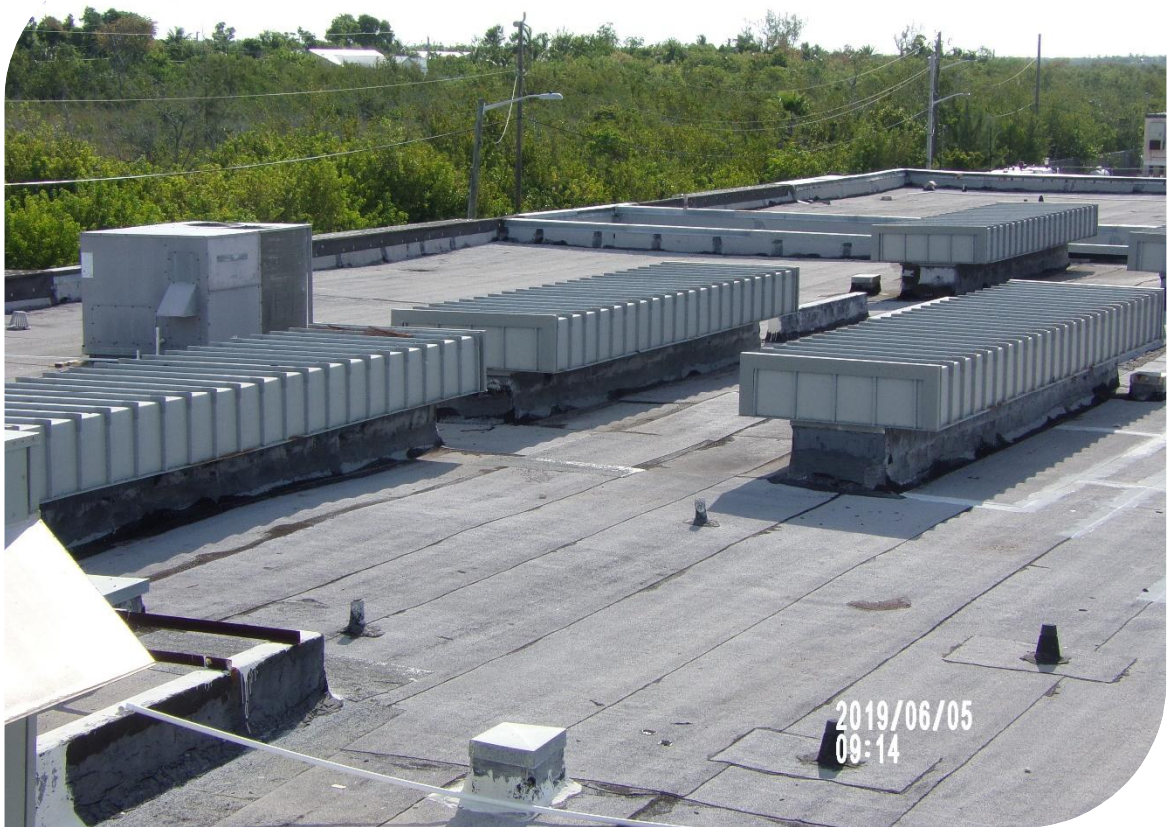
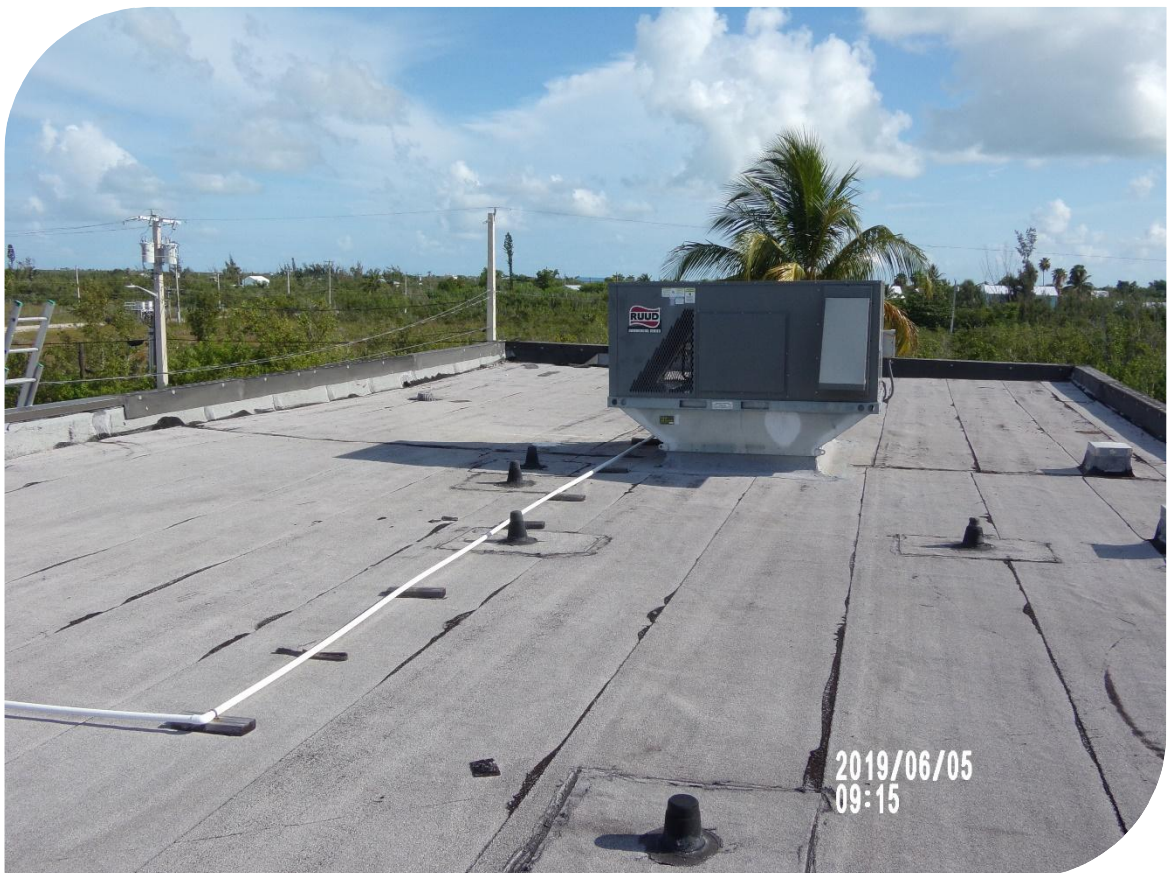
Many vulnerable roof penetrations

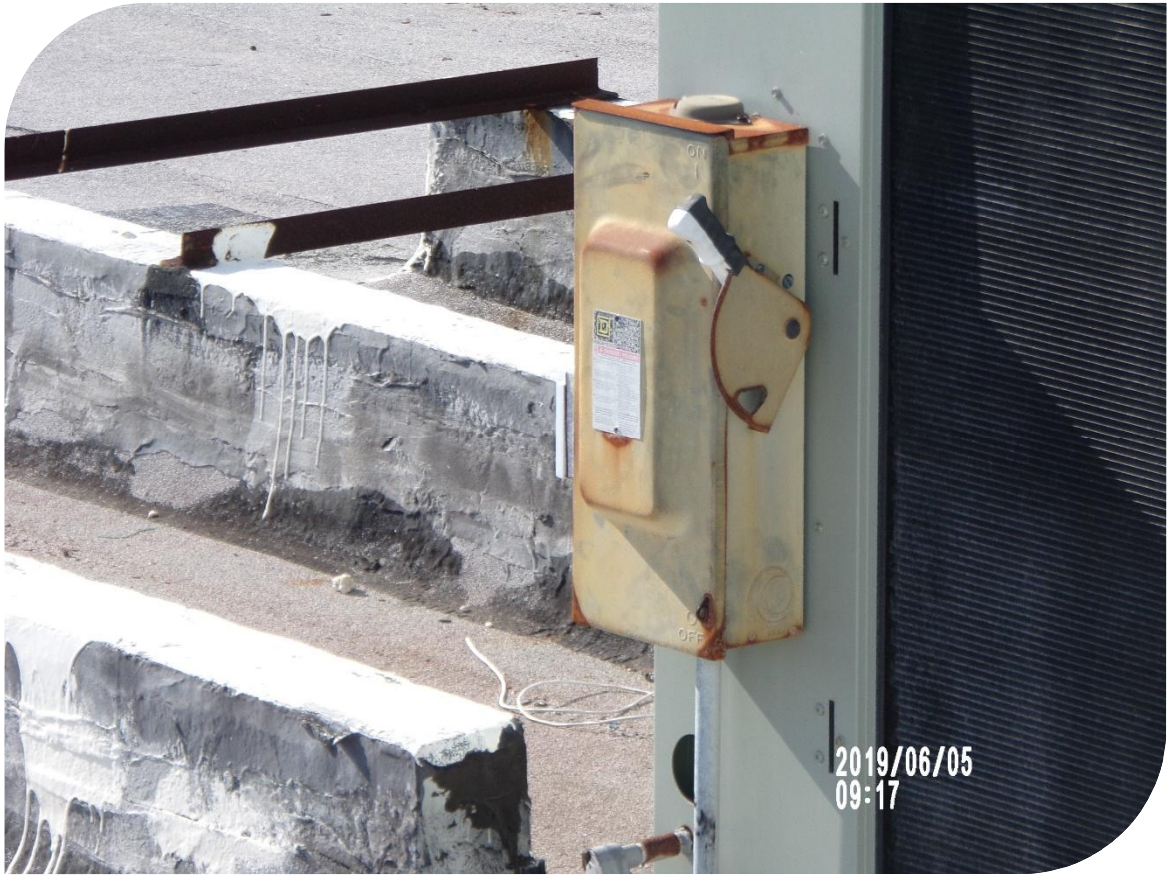
Aging equipment

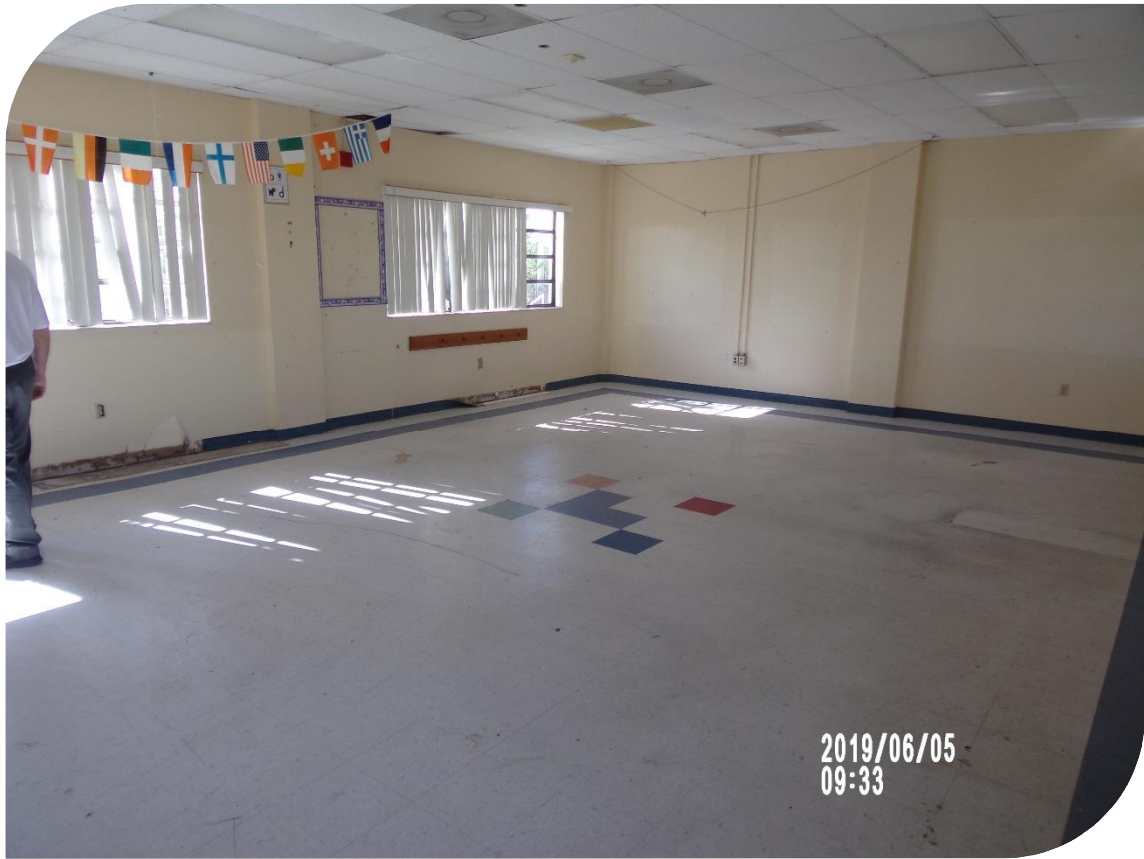
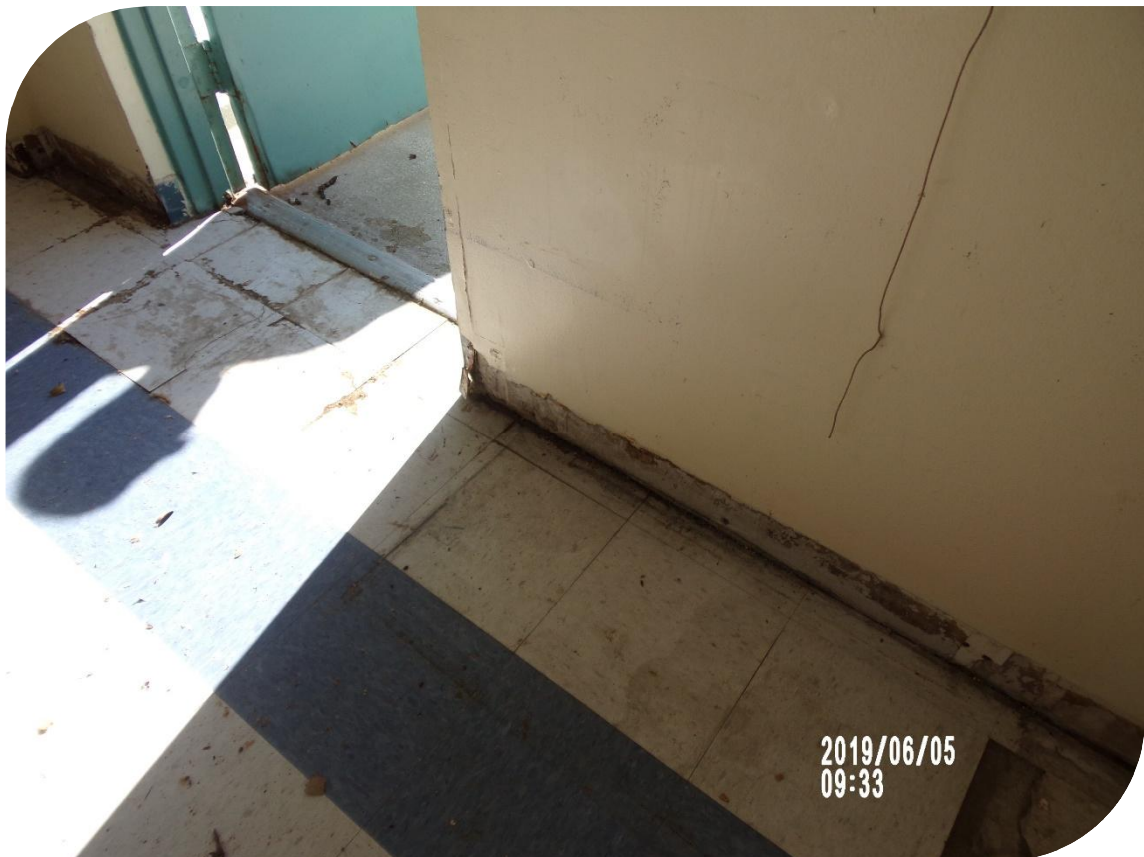
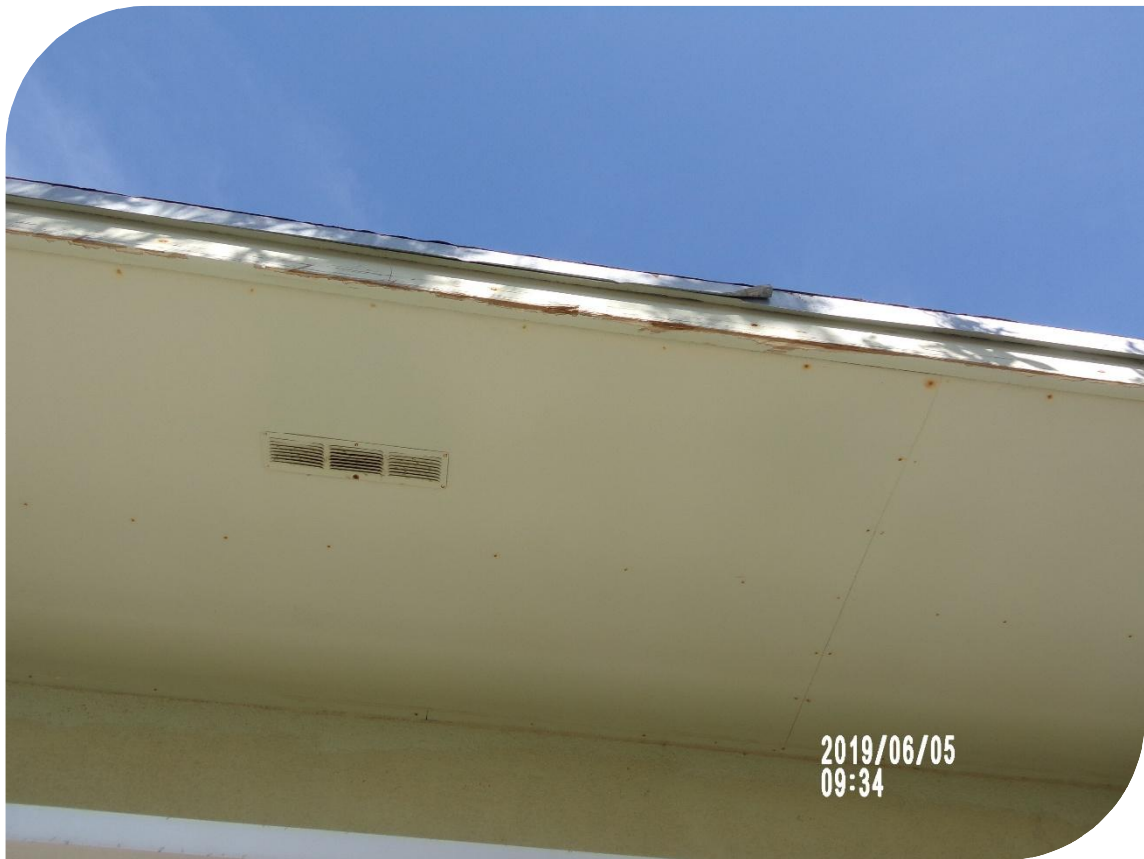
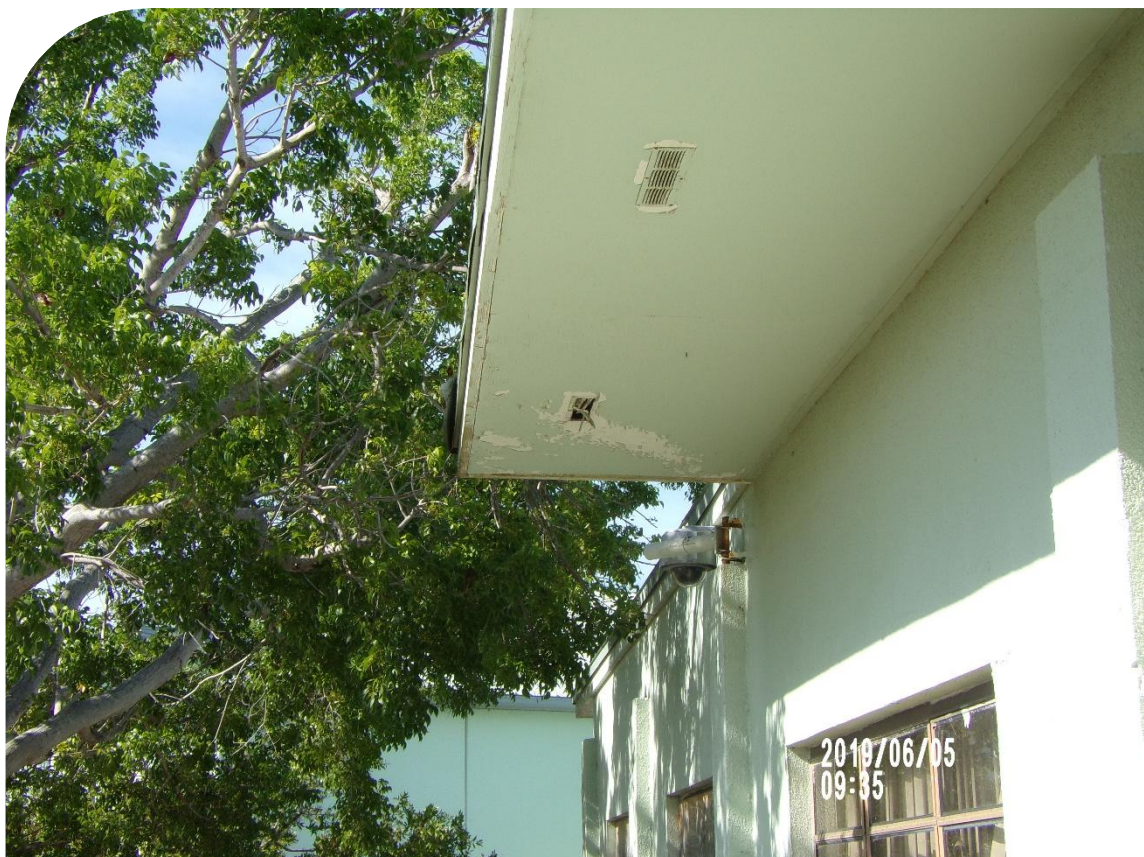
Moisture intrusion at base

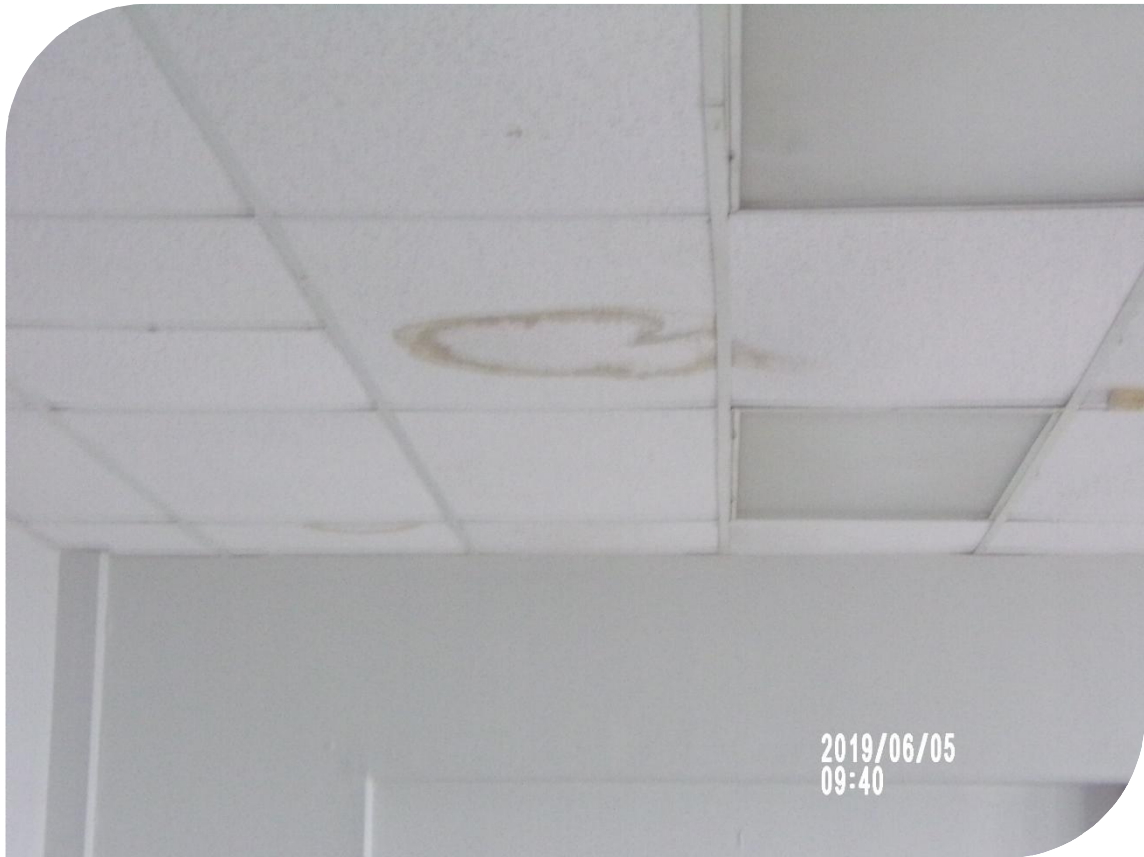
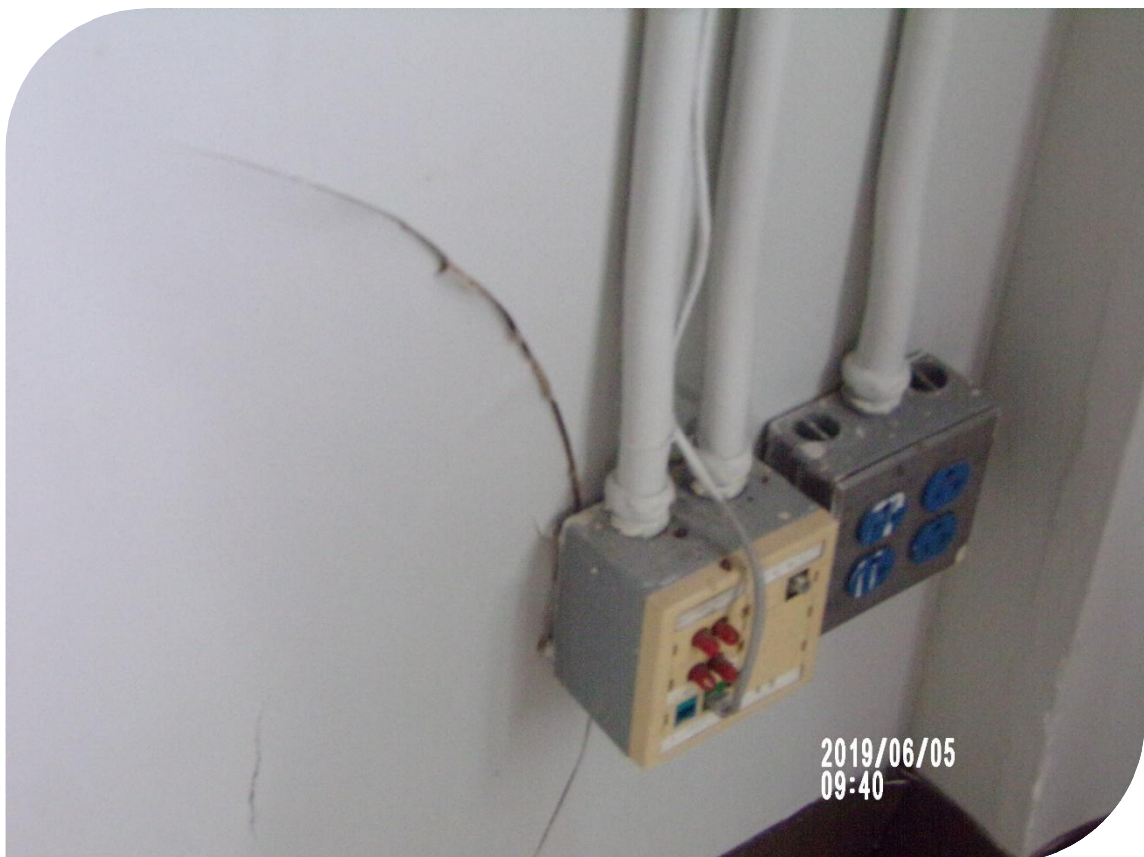
Moisture Intrusion
